**IDENTIFICATION OF POTENTIAL ENVIRONMENTAL
PROBLEMS AT PORT RADIUM.**

FIELD REPORT:

In search of uranium mill tailings.

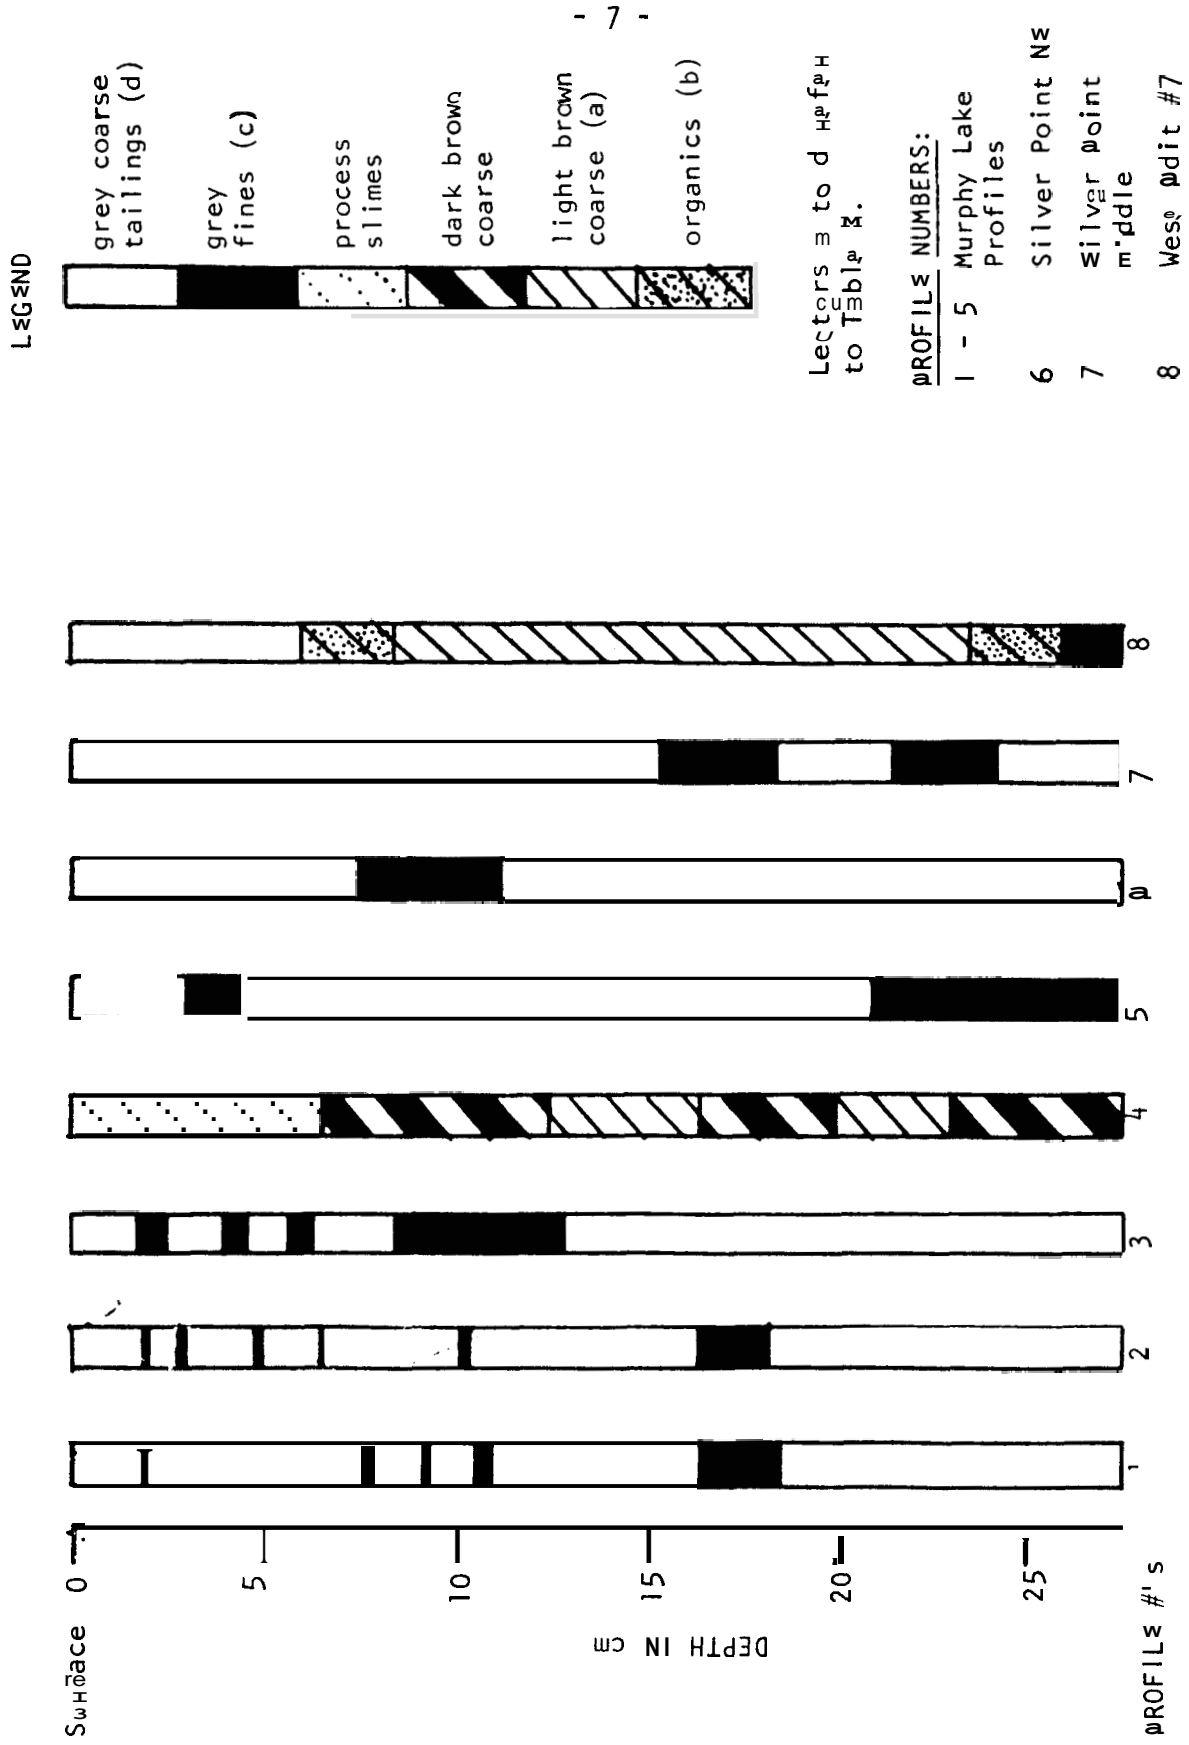
Figure 1: Vertical profiles in pits of exposed tailings areas.

By excavating small pits in these tailings, some layers of fines were differentiated (Figure 1, Profiles 6 & 7). The fines have a slightly higher electrical conductivity than the coarse tailings. Some water soluble material is probably contained in the fines. The electrical conductivity increased in fine tailings slurries after 24 h to 600 $\mu\text{mhos/cm}$ from an initial reading of 300 $\mu\text{mhos/cm}$.

A profile located close to the edge of the former lake (Figure 1, Profile 4), has brown layers of more acidic sandy material (pH 3.2 to 5.4, Table 2). Weathered coarse brown sand was collected in the area of Cross Fault Lake on the slopes where extensive trenching has occurred. These materials when slurried gave a pH value of 3.0 and an electrical conductivity of 1600 $\mu\text{mhos/cm}$. Coarse brown sandy material also surrounds Murphy Lake. A belt of horsetails (*Equisetum arvense* L.) grow immediately adjacent to the tailings area, on such weathered sand. This material, however, has a neutral pH ranging from 6.3 to 7.4 and a low electrical conductivity of 160 to 540 $\mu\text{mhos/cm}$. The brown sand on the shores of Murphy Lake are neutral, possibly neutralized by the tailings liquors. Unfortunately, no material was collected from

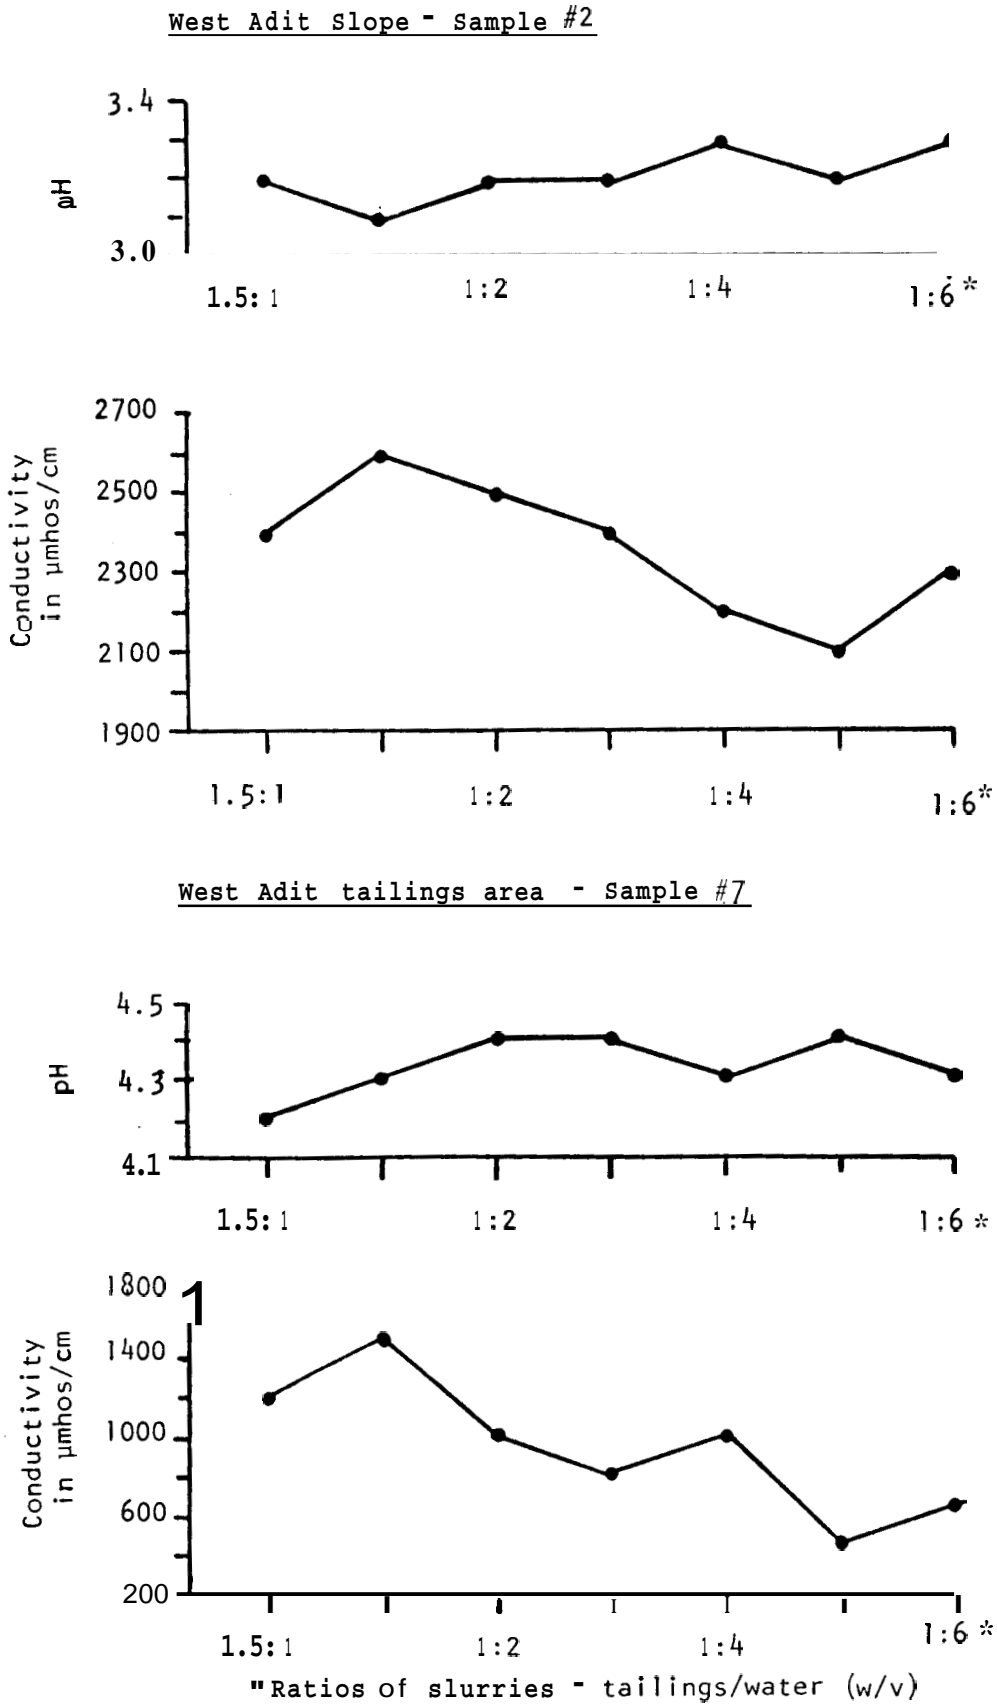
Figure 2: West Adit tailings slurries.

In Figure 2, different ratios of distilled water and tailings are plotted for the resulting pH values and the electrical conductivities of the slurries. For both selected tailings samples the slurries remained acidic regardless of the distilled water and the tailings ratio. The electrical conductivity decreased more for the coarse tailings in sample # 7 than for those of sample # 2 located on the slopes. This may be a reflection of the weathering and the drainage of the West A dit area. The location of which sample # 7 was collected was wet and drained poorly, whereas the sloped area was dry from which sample # 2 originated.

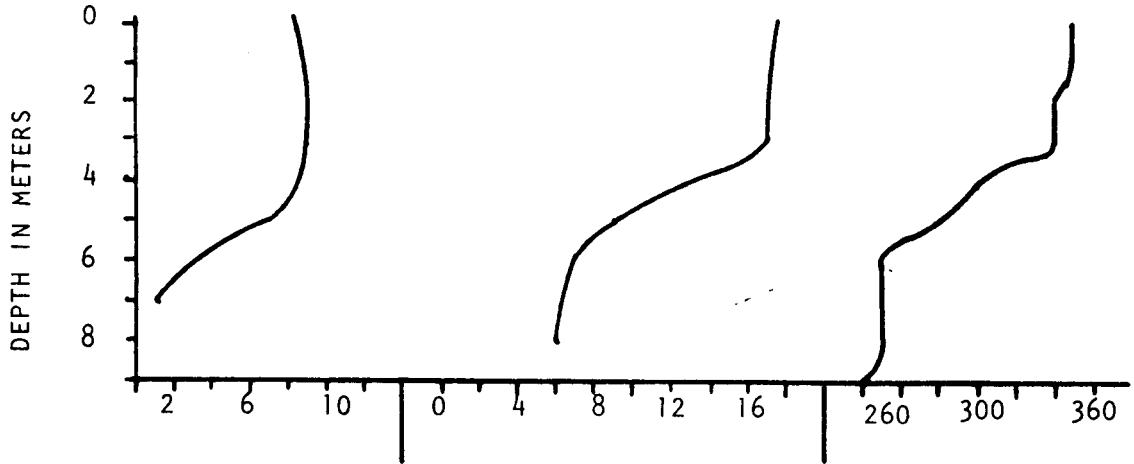
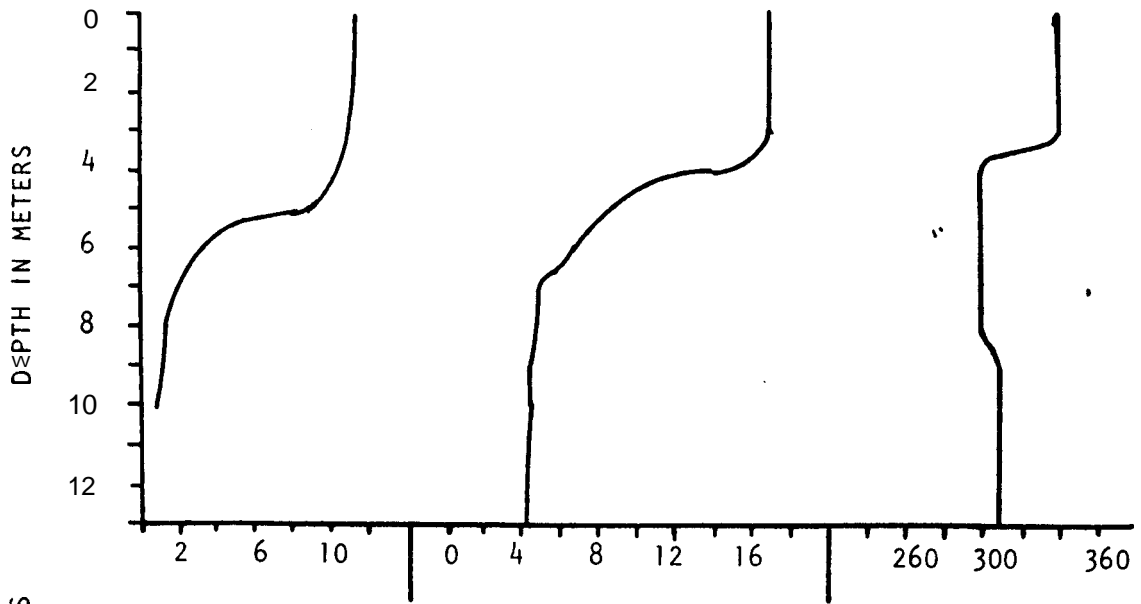
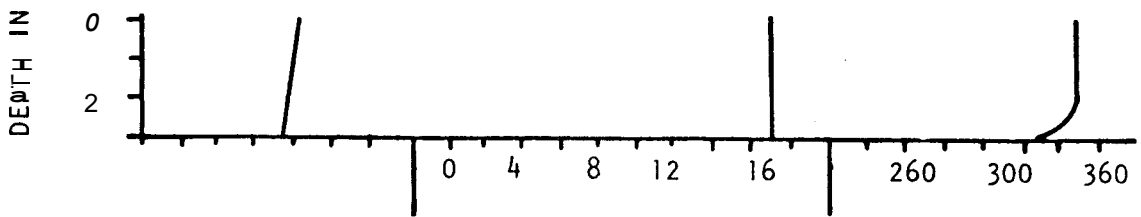
Figure 4: Water column of Garbage Lake.

electrical conductivity (Figure 4) indicate that some stratification occurs at 4 to 6 m depth. The decrease in electrical conductivity in the water is accompanied by a decrease in temperature which is to be expected. The lower portion of the water column is free of oxygen. On the shallow tailings beaches (Figure 4 - sample site 7) the water characteristics are identical to those of the upper part of the water column. The analysis of sediments and the water may facilitate the determination of some important dynamic environmental characteristics of this tailings area for the long-term.

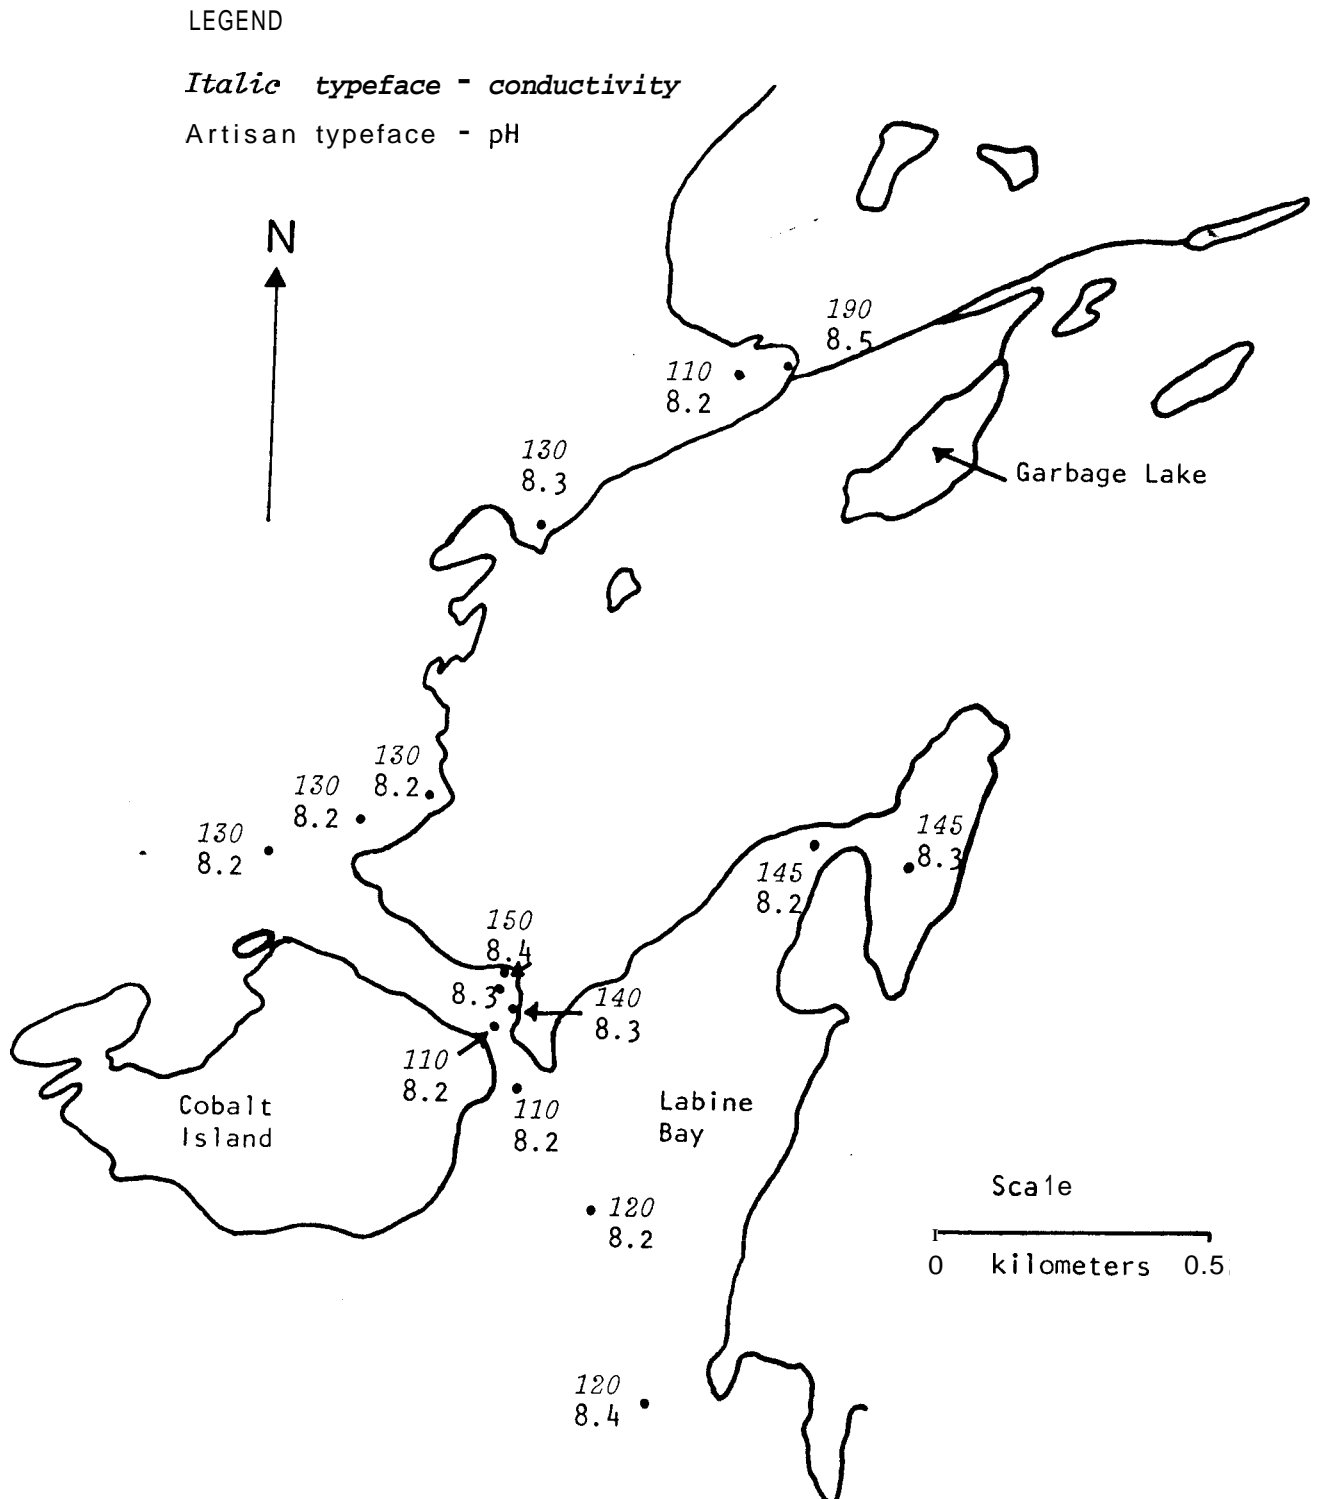
Figure 5: Field measurements of pH and conductivity in surface water around the Port Radium Peninsula.

In Figure 5, the pH values and the electrical conductivities of the water within the first 1 m from the surface are given. Locations of these measurements are indicated by dots in Figure 5. From the results of the shoreline survey, the pH of the water is consistently around pH 8.2 to 8.3. The electrical conductivity increases slightly on the beaches of Bear Bay, Murphy Creek, Silver Point tailings and in Labine Bay. This increase may be a result of dissolved material from the tailings, but the dilution is rapid and the increase small. However, in order to substantiate the slight increase ranging from 110 to a maximum of 190 $\mu\text{mhos/cm}$ at the Bear Bay beach, repeated measurements would be required at different times throughout the year and under conditions of comparable wave action and weather. The shoreline survey was carried out during relatively calm waves, whereas the measurements on Murphy Bay and Cobalt Channel were obtained during considerable winds. The observed increase in electrical conductivity may

thus be an artifact of the different wave action.

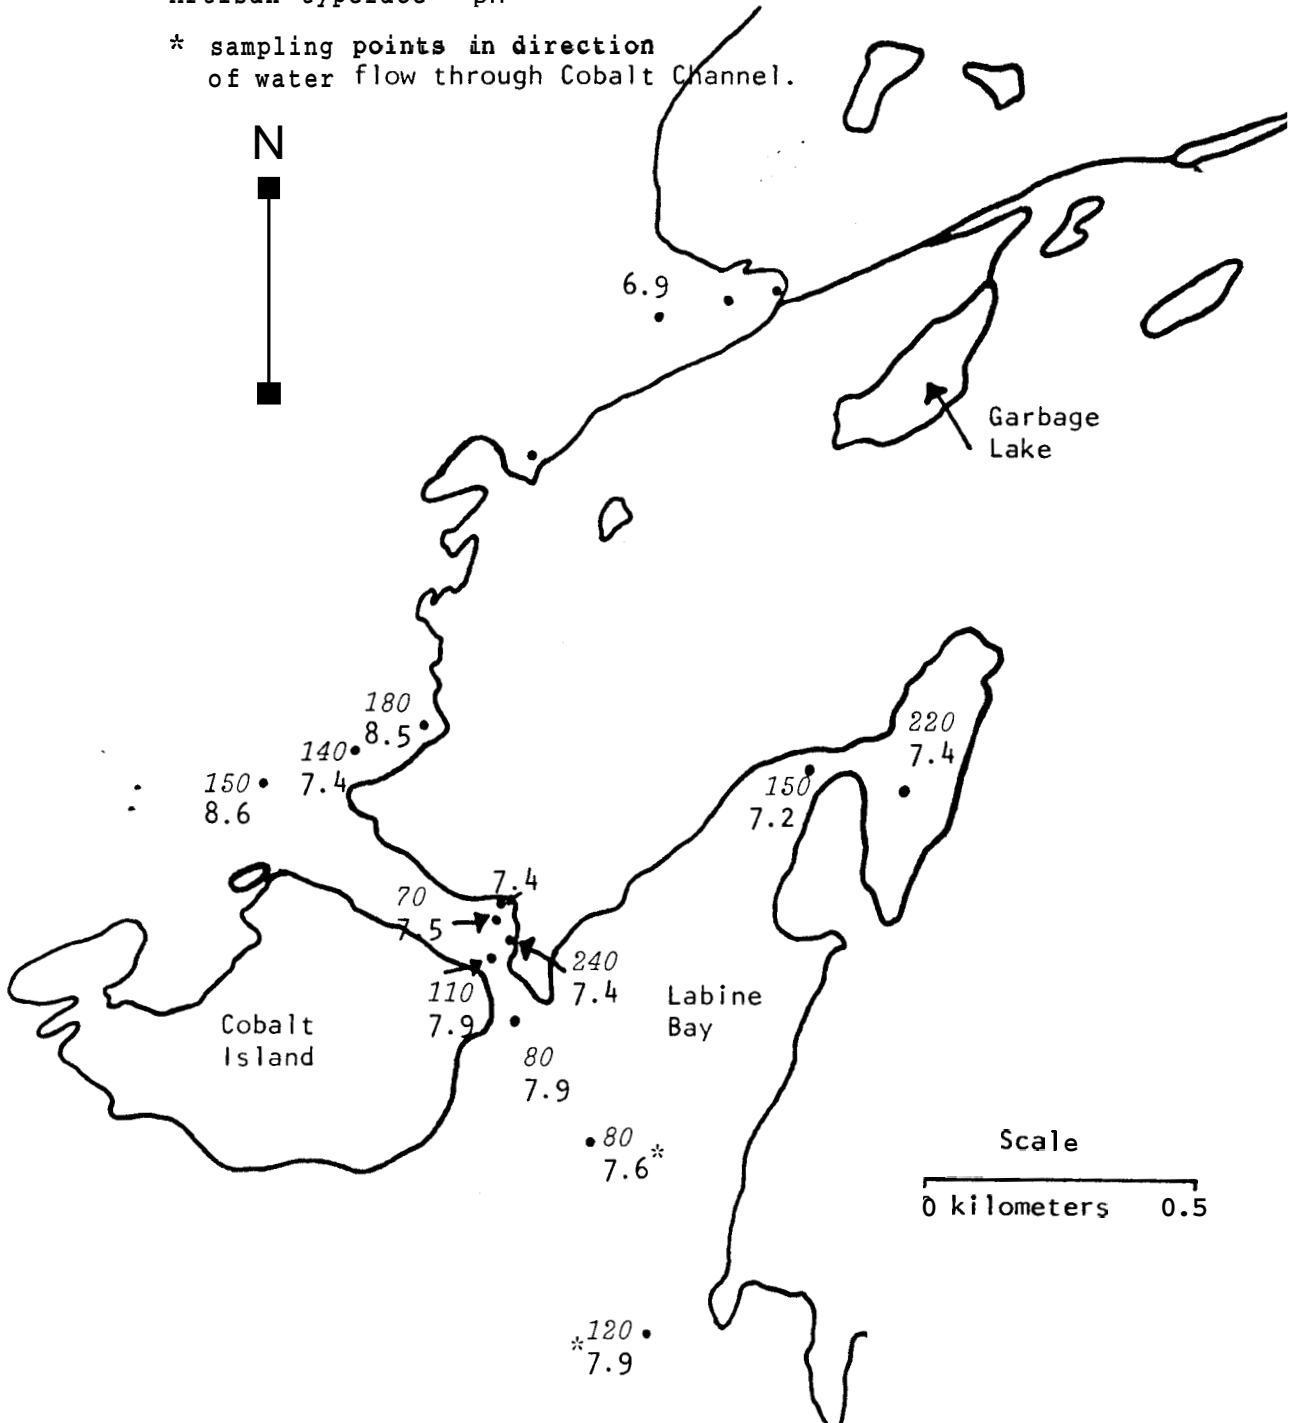
Figure 6: Field measurements of pH and conductivity for sediment or tailings around Port Radium Peninsula.

Comparison of the pH values and the electrical conductivities of the sediments (Figure 6) obtained from the same locations as the surface water reported earlier (Figure 5) showed that the sediment values were generally similar to those for the overlying water column. The sediments are slightly less alkaline, although the range of electrical conductivities is slightly larger from 80 to 240 $\mu\text{mhos/cm}$. The significance of these different conductivities may lie in the character of the sediment.

Visually gyttja (natural lake sediment) can be easily separated from tailings. If an Eckman grab was brought to the surface carefully, the material could be separated and immediately pH, electrical conductivity and oxygen concentrations were ~~measured~~. When such a sampling procedure was successful, it was found that gyttja generally had a higher electrical conductivity, the same pH as tailings and both materials were free of oxygen. The sediments were sampled, separating the material such that a differentiation by chemical analysis would be possible. Samples at the mouth of Labine Bay, in the direction of water flow through Cobalt Channel (indicated by stars in Figure 6), contained generally tailings and gyttja. The thickness of the tailings layer decreased with distance from Cobalt Channel, i.e., the Silver Point tailings beach. All of the sediment samples were free of oxygen.

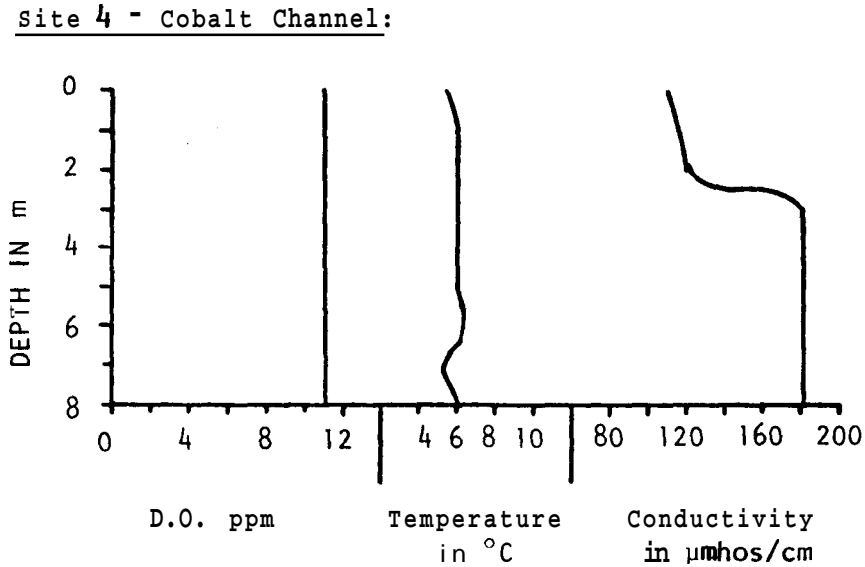
Figure 7: Water column characteristics in the middle of Cobalt Channel.

The water column was investigated in Cobalt Channel (Figure 7). The lower electrical conductivity of the uppermost 2 m of the water column is probably a result of extremely strong winds in the morning of that day on which the profiles were obtained. Off-shore water with lower conductivity did not have sufficient time to mix with the deeper waters. On the other hand the difference may be a measurement artifact given that the instrument failed shortly after these measurements. Based on oxygen concentrations and temperature the water appeared completely mixed at sample site # 4 in the middle of the Channel across from the Silver Point tailings beach. Unfortunately, because of equipment failure, it was not possible to obtain similar data on sampling pints in Labine Bay and at the mouth of Labine Bay.
