**Development of a Pit Lake  
And  
Fate of Contaminants  
1992-2001**

**July 2002**

## EXECUTIVE SUMMARY

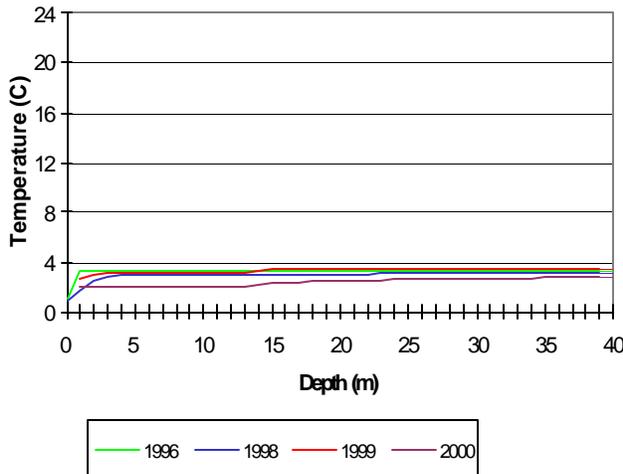
**Fig. 1a: Flooded Pit, March-May  
Temperature vs Depth, 1996 - 2000**

Appendix 2 provides depth profiles for temperature (Figure 1a to 1d) for 1997-2001. No thermocline was evident in June, 1999, but by July, 1999 was present to a depth of about 5 m increasing 7 m prior to winter. The same pattern was noted in 2000 and 2001 where a very deep thermocline formed to a depth of 17 m by the end of 2001.

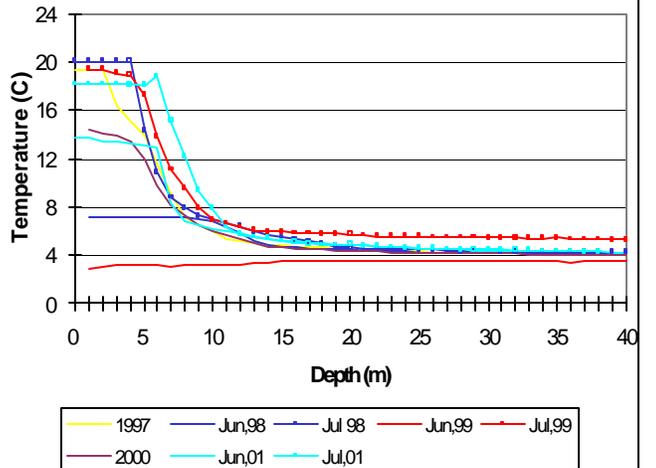
**Fig. 1b: Flooded Pit, June-July  
Temperature vs Depth, 1997-2001**

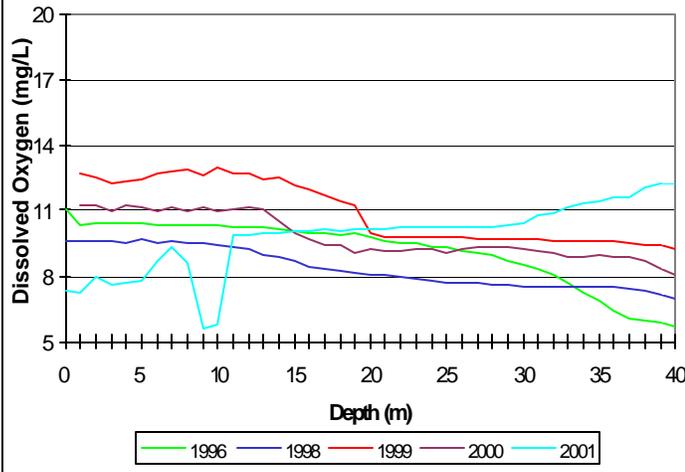
**Fig. 2a: Flooded Pit, March-May  
Dissolved Oxygen vs Depth, 1996 - 2001**

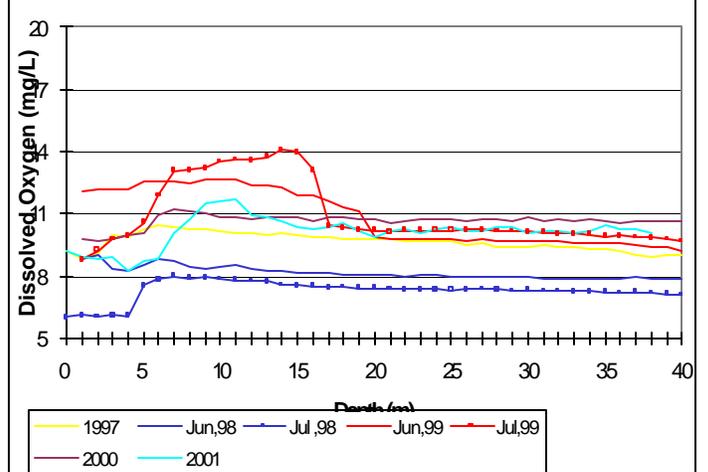
**Fig. 2b: Flooded Pit, June-July  
Dissolved Oxygen vs Depth, 1997-2001**

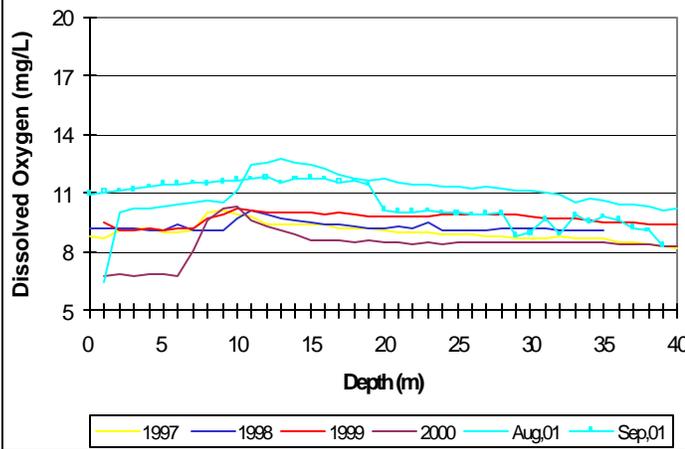
**Fig. 2c: Flooded Pit, August-September  
Dissolved Oxygen vs Depth, 1997-2001**

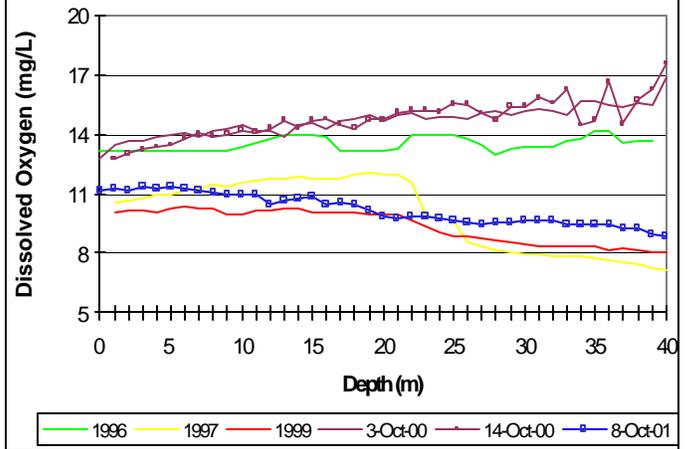
**Fig. 2d: Flooded Pit, October  
Dissolved Oxygen vs Depth, 1996 - 2001**

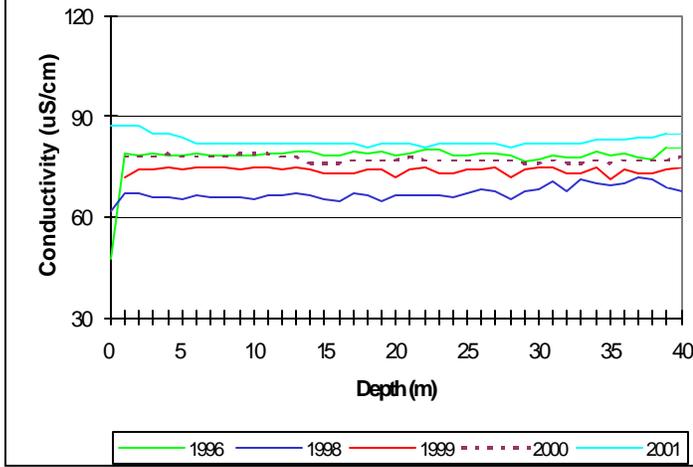
**Fig. 5a: Flooded Pit, March-May  
Conductivity vs Depth, 1996-2001**

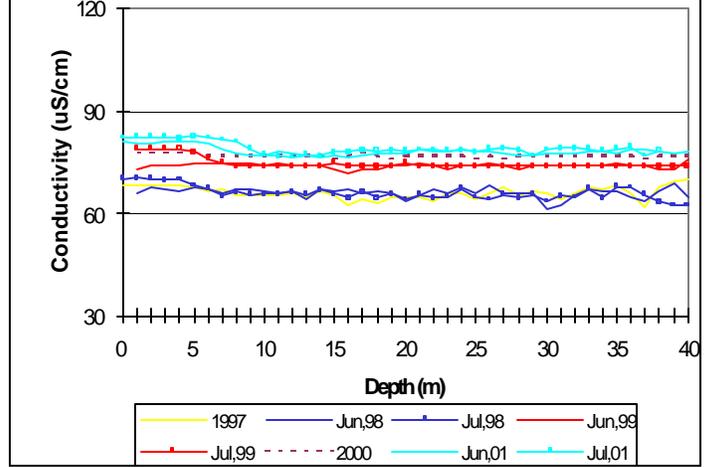
**Fig. 5b: Flooded Pit, June-July  
Conductivity vs Depth, 1997-2001**

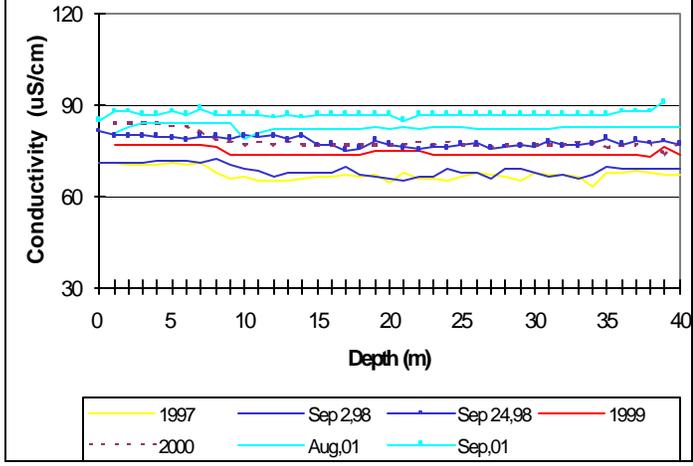
**Fig. 5c: Flooded Pit, August-September  
Conductivity vs Depth, 1997-2001**

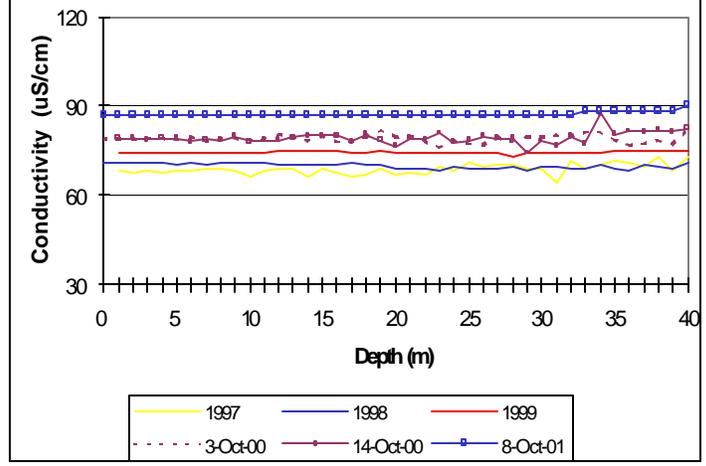
**Fig. 5d: Flooded Pit, October  
Conductivity vs Depth, 1997-2001**

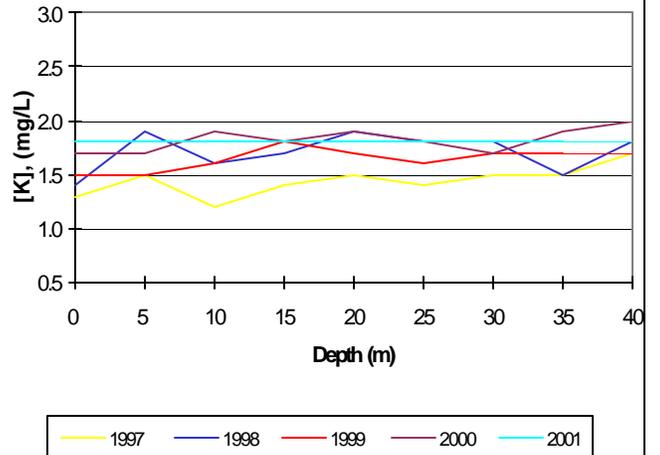
**Fig. 7b: Flooded Pit, June-July  
Potassium Concentration, 1997-2001**

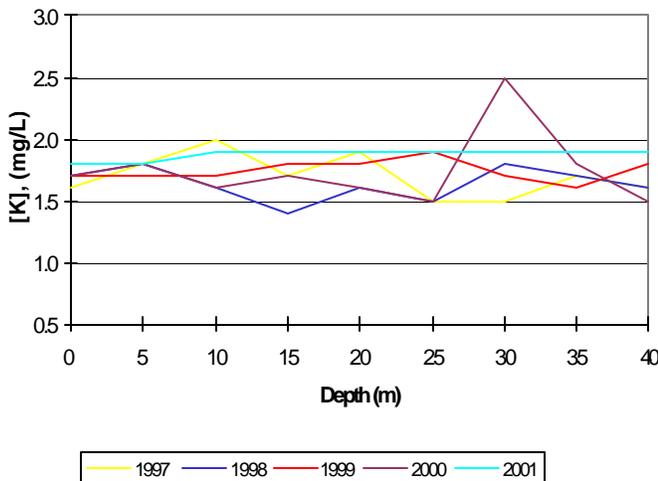
**Fig. 7c: Flooded Pit, August-September  
Potassium Concentration, 1997-2001**

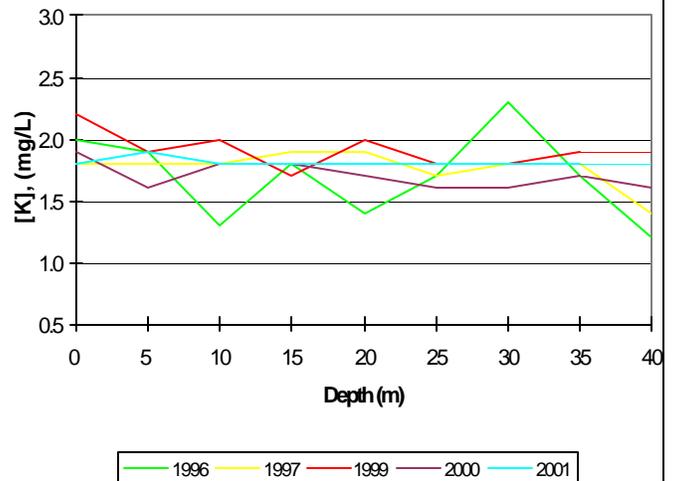
**Fig. 7d: Flooded Pit, October  
Potassium Concentration, 1996-2001**

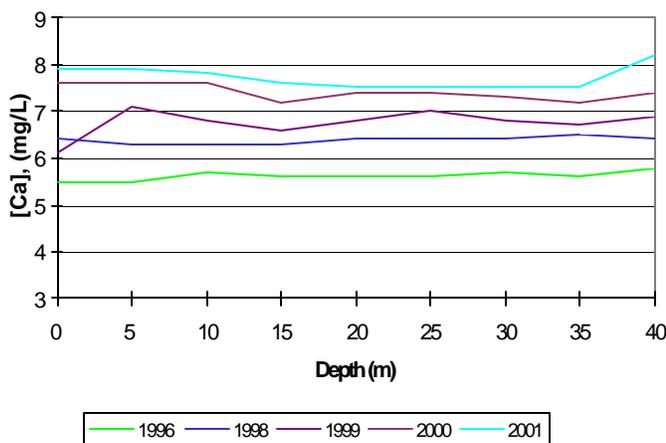
**Fig. 9a: Flooded Pit, March-May  
Calcium Concentration, 1996-2001**

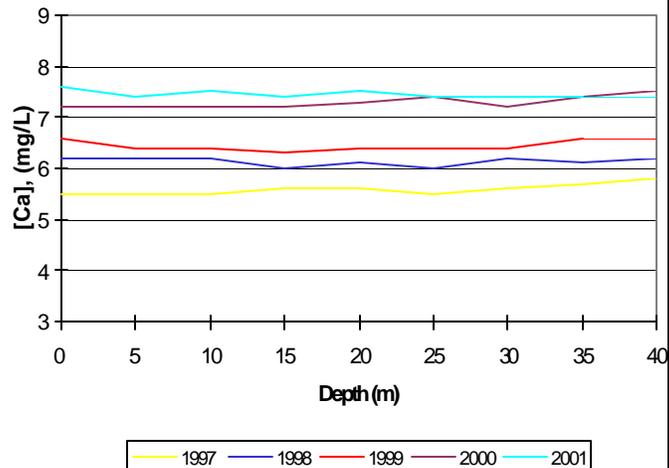
**Fig. 9b: Flooded Pit, June - July  
Calcium Concentration, 1997-2001**

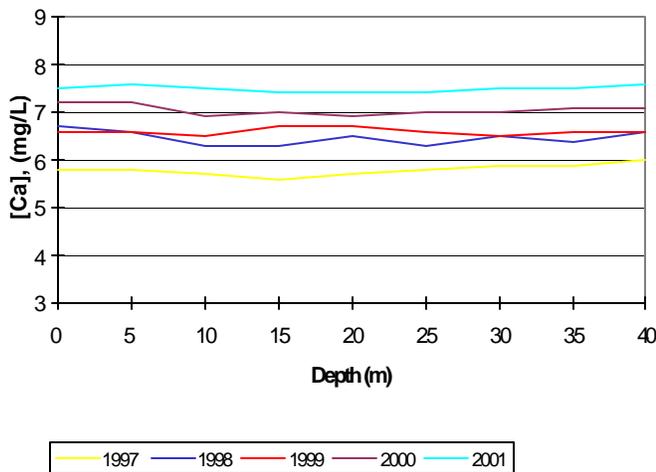
**Fig. 9c: Flooded Pit, August-September  
Calcium Concentration, 1997-2001**

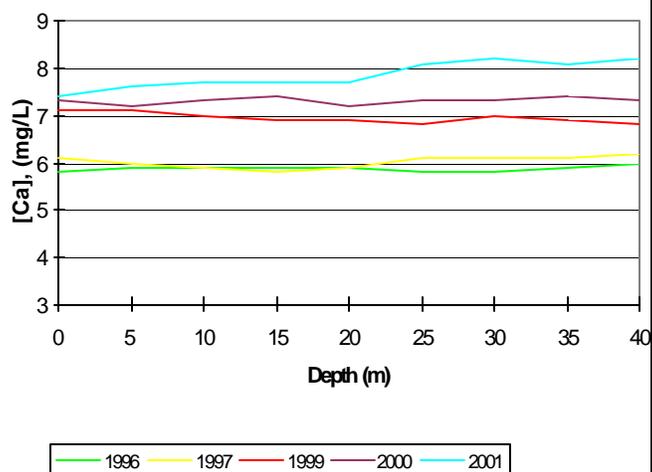
**Fig. 9d: Flooded Pit, October  
Calcium Concentration, 1996-2001**

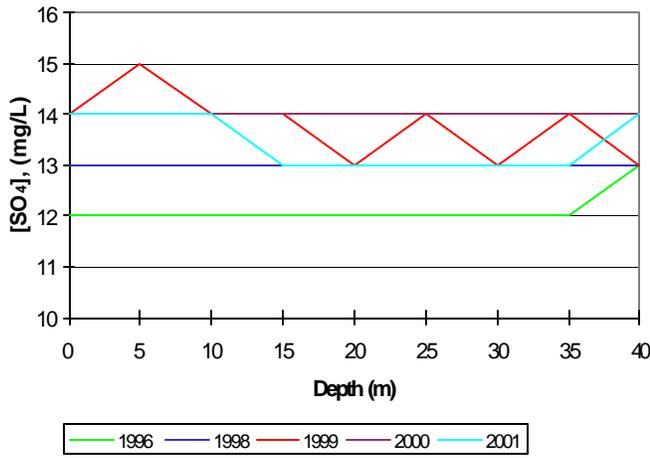
**Fig. 10a: Flooded Pit, March-May  
Sulphate Concentration, 1996-2001**

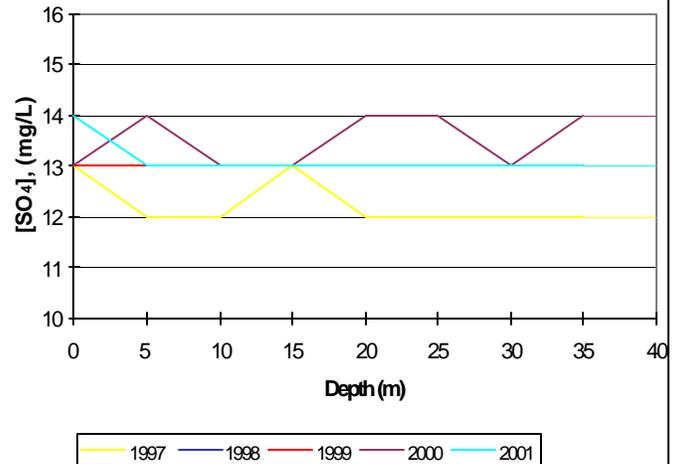
**Fig. 10b: Flooded Pit, June - July  
Sulphate Concentration, 1997-2001**

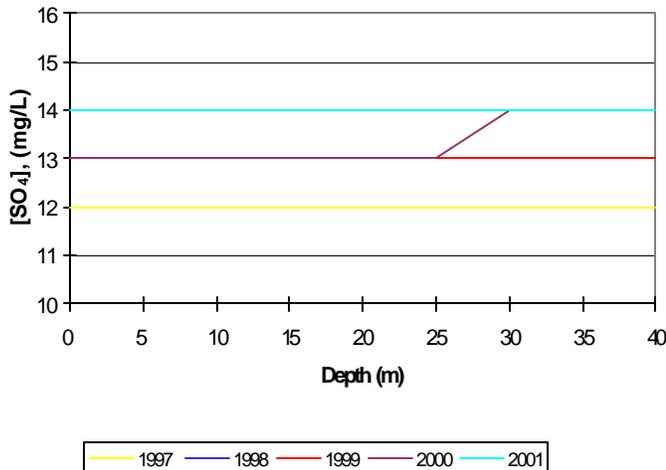
**Fig. 10c: Flooded Pit, August-September  
Sulphate Concentration, 1997-2001**

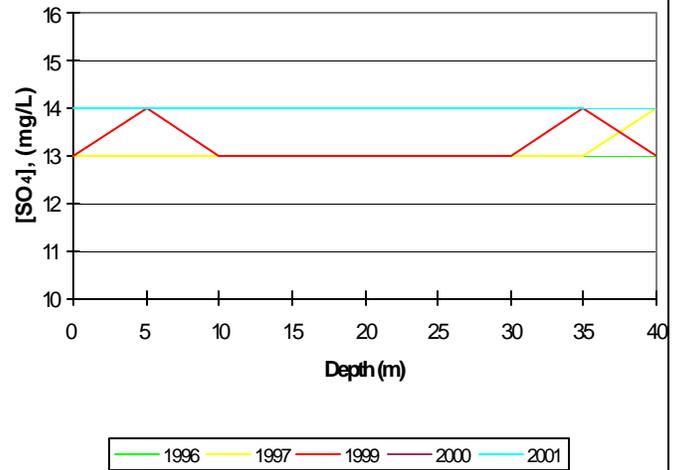
**Fig. 10d: Flooded Pit, October  
Sulphate Concentration, 1996-2001**

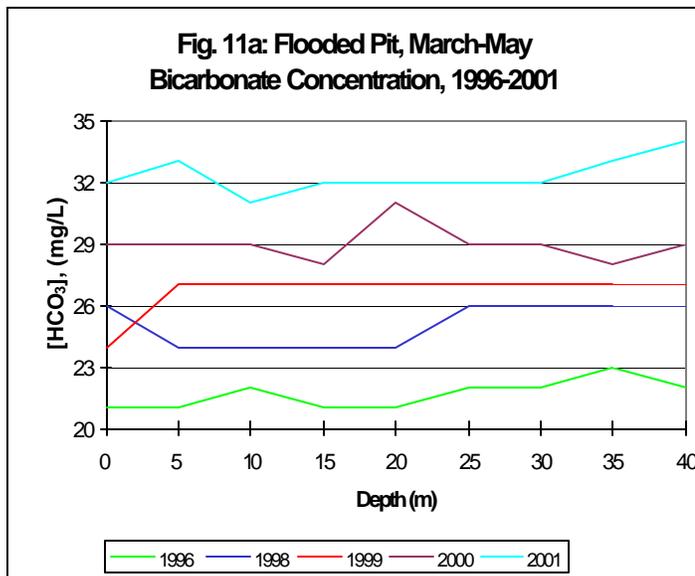
**Fig. 11a: Flooded Pit, March-May  
Bicarbonate Concentration, 1996-2001**

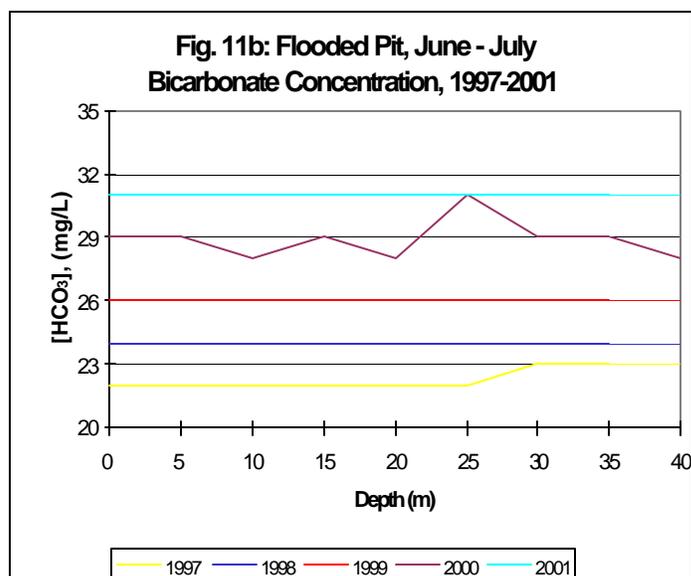
**Fig. 11b: Flooded Pit, June - July  
Bicarbonate Concentration, 1997-2001**

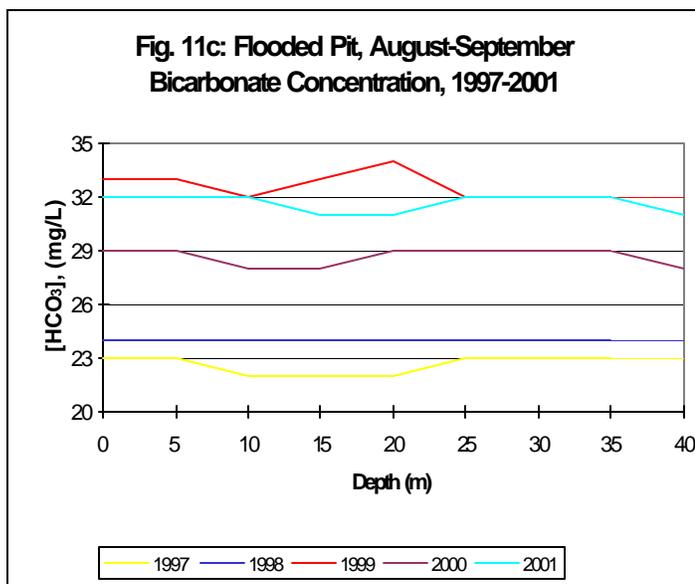
**Fig. 11c: Flooded Pit, August-September  
Bicarbonate Concentration, 1997-2001**

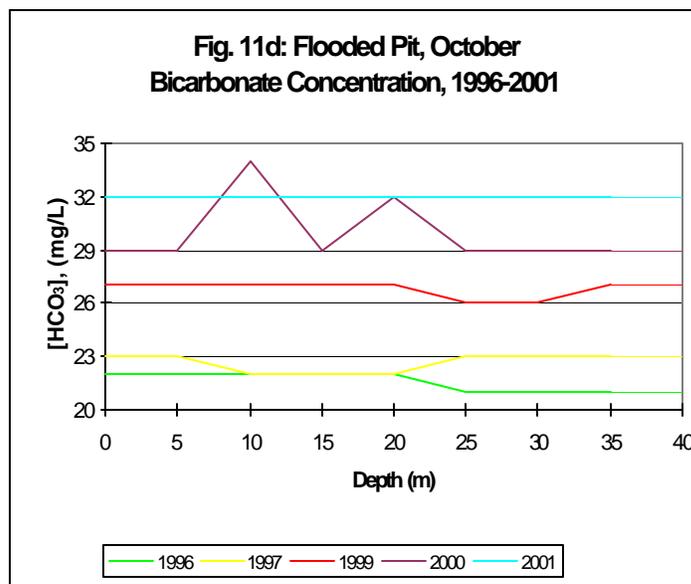
**Fig. 11d: Flooded Pit, October  
Bicarbonate Concentration, 1996-2001**

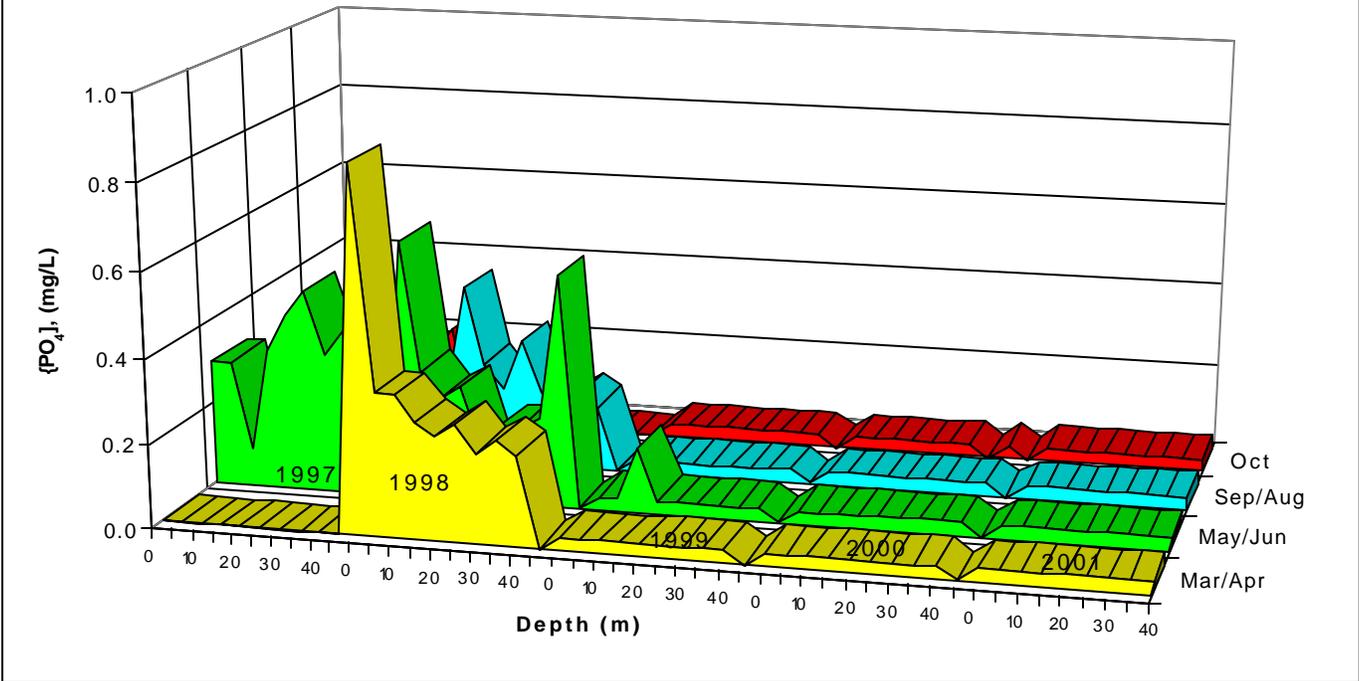
**Fig. 12: Flooded Pit, 1997-2001 Data  
PO<sub>4</sub> vs Depth**

Figure 12 (Appendix 2) provides phosphate concentrations. These have been low since 1999 and by 2000 were either close to or at the analytical detection limit. However it should be noted, that even such low concentrations can support biological activity. Figure 13 (Appendix 2) shows that at the end of the 2001 growing season, the changes in concentrations of NO<sub>3</sub>, which increase with depth, were particularly pronounced suggesting some microbial activity. Ammonia concentrations in the pit lake which were generally low (below or at 0.05 mg/L) in 1993-1996, (page 32 of the 1997 report) were at or above 0.1 mg/L by the year 2001. Again, the highest readings were obtained at the end of the summer (Figure 14, Appendix 2).

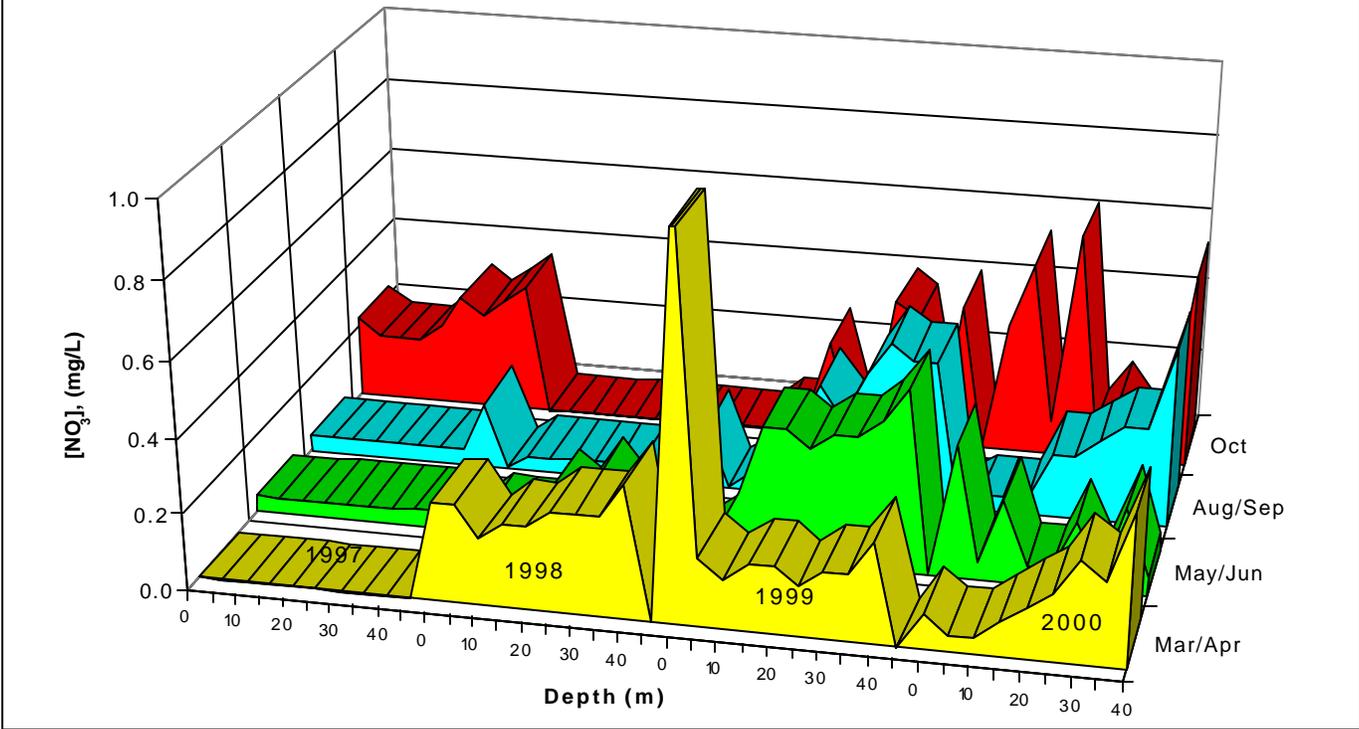
**Fig. 13: Flooded Pit, 1997-2000 Data  
NO<sub>3</sub> vs Depth**

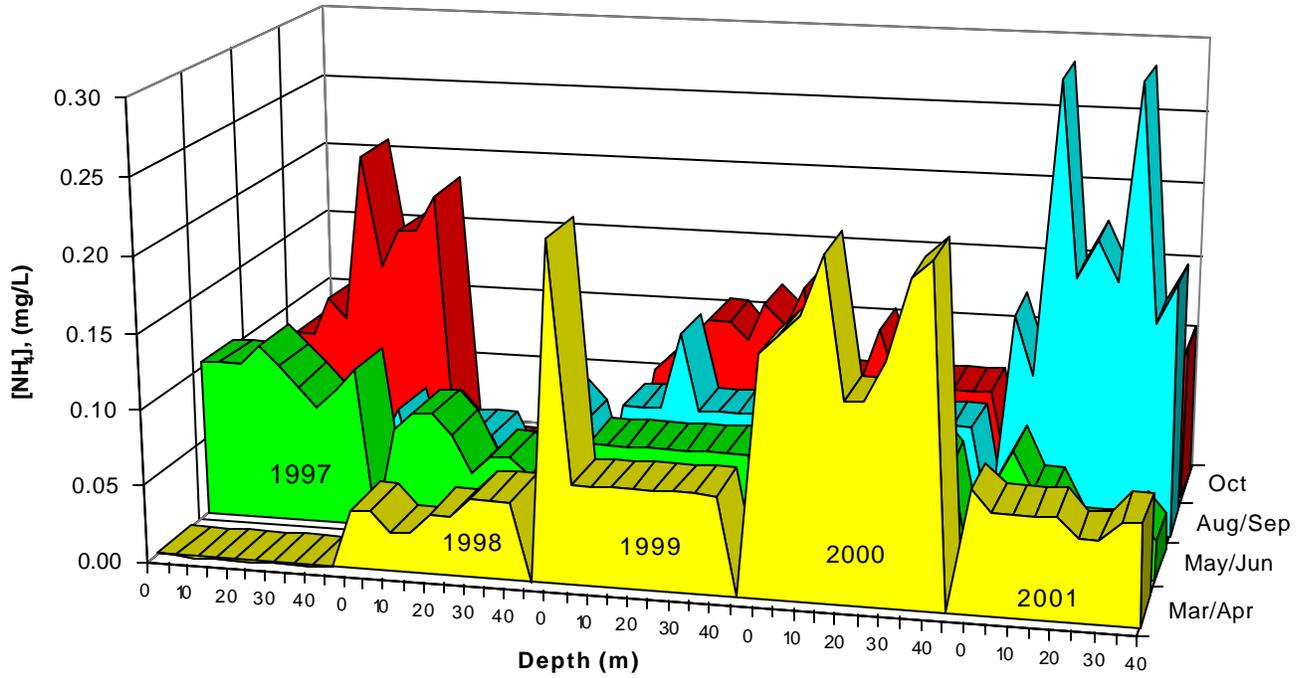
Fig. 14: Flooded Pit, 1997-2001 Data  
NH<sub>4</sub> vs Depth

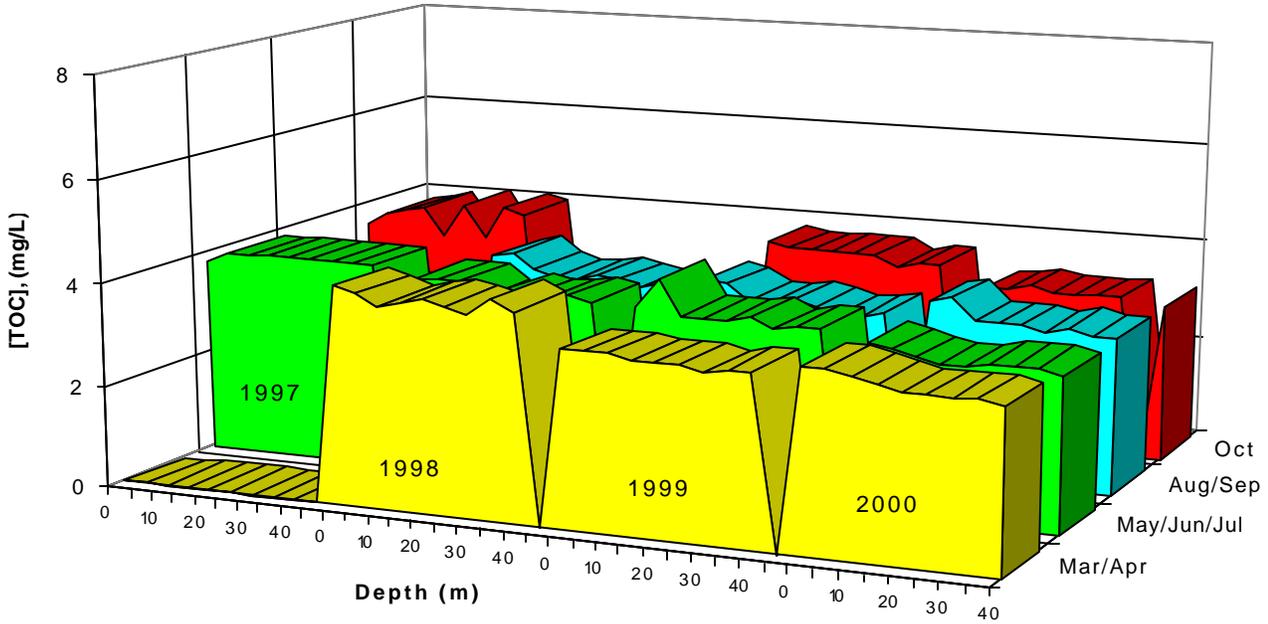
**Fig. 15: Flooded Pit, 1997-2000 Data  
Total Organic Carbon vs Depth**

Total organic carbon concentrations (TOC) changed little up to 2000 (Figure 15, Appendix 2). A slight increase was noted in the fall of 2000 to values of 6 mg/L which may reflect an opportunistic fall algal bloom, quite likely due to the changing nutrient conditions. Finally, TSS which remained at or below 5 mg/L before 1996 (Figure 16, Appendix 2), dropped substantially by 1998 to around 2 mg/L or less throughout the pit.

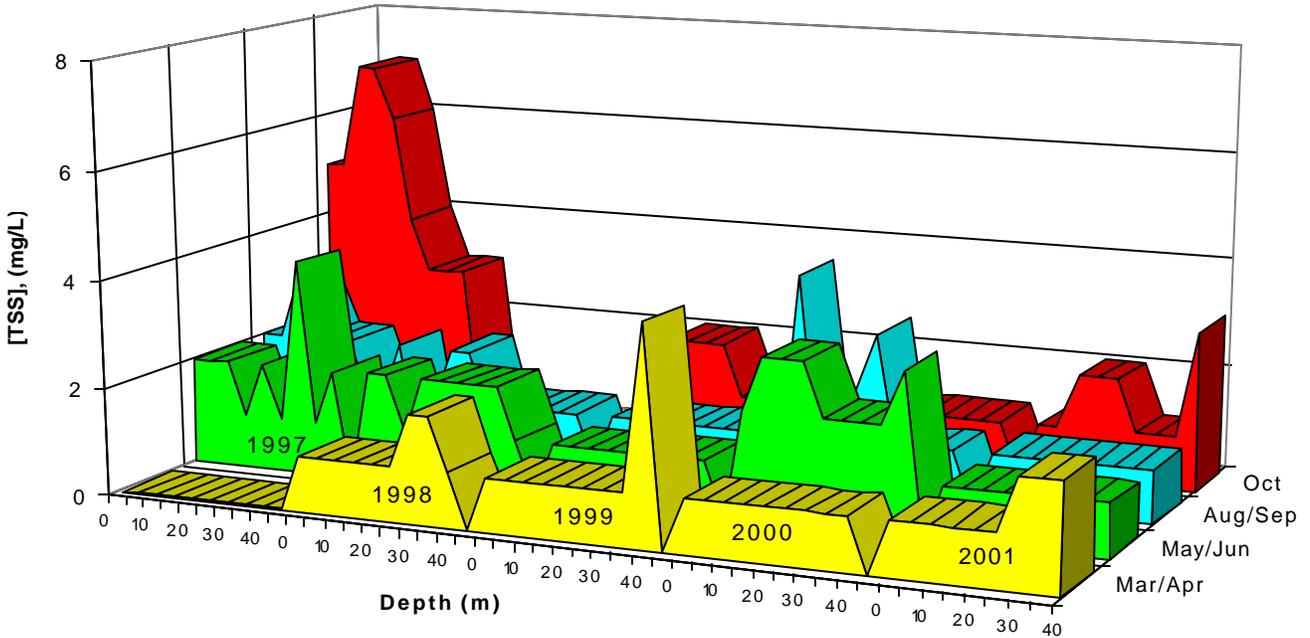
**Fig. 16: Flooded Pit, 1997-2001 Data  
Total Suspended Solids vs Depth**

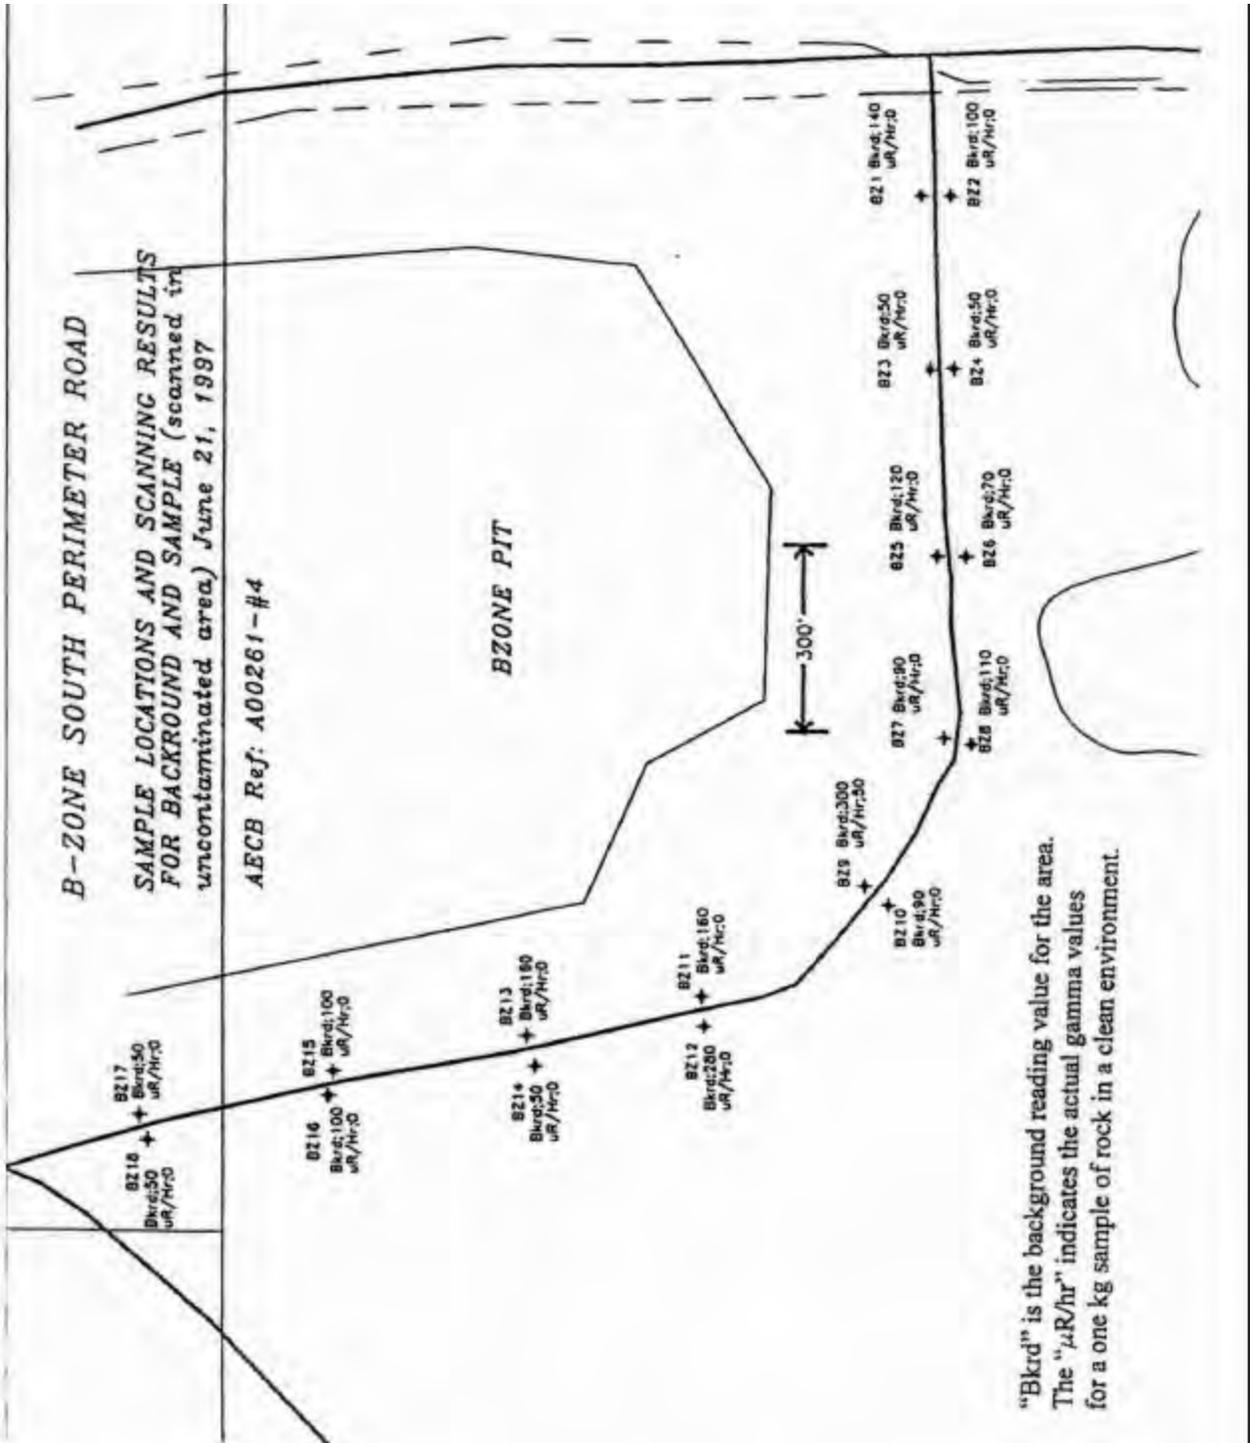
Map of B-Zone Pit southwest perimeter road bed waste rock sampling locations (M.Baldero, Cameco, June, 1997)

The potential of the blue road as a source of Ni was evaluated during summer field trips by Boojum Research in 1999 and 2000. A series of water and solid samples were collected during a rainfall from puddles in the blue areas. In addition, during a rainfall event, a series of water and solid samples were collected from puddles in the blue area. The locations at which run-off from rain enters the pit lake were easily identified by the presence of filamentous algal and iron hydroxide staining. The run-off samples contained concentrations of Ni as high as 44 mg/L Ni while a filtrate prepared from surface evaporite material produced concentrations of 1,530 mg/L of Ni. Concentrations of Ni in ground water seepages were generally lower, ranging from 0.036 mg/L to 1.14 mg/L while As ranged from 0.03 mg/L to 1.7 mg/L (Table 1a, Appendix 5). The sampling locations are reported in Table 1a and 1b and on Map 1 in Appendix 5)

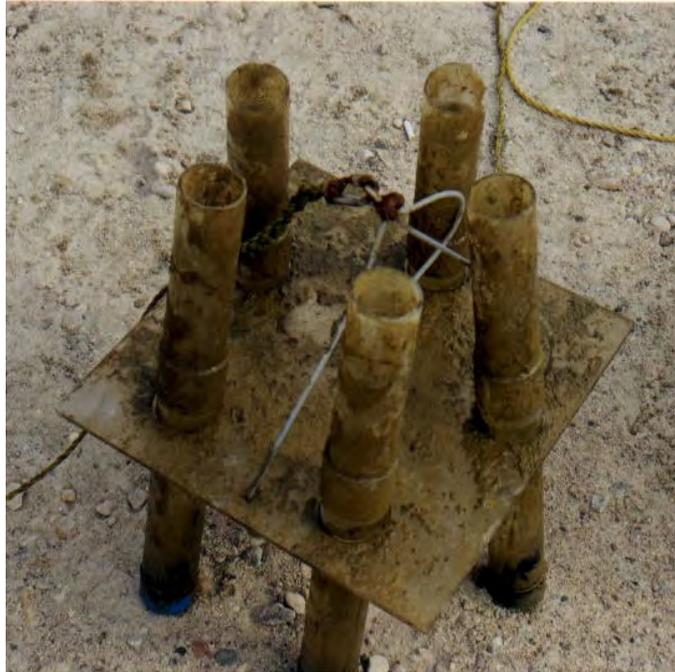
App4-Plate 1: B-Zone sedimentation trap collected at station 6.72 from 2m depth.

Evidence that contaminant removal is related to TSS or particulate material is found in Plate 1 where the sedimentation traps for the year 2000 are depicted. This photo indicates clearly a heavy TSS loading on the surface sedimentation trap. The coverings appear to be formed of a slimy film combining organic with inorganic particulate matter. This coating was not present in earlier years. In summary, an active biological component is feasible, but can not be substantiated solely based on analysis of sedimentation trap contents. Analysis of the solid material collected in the sedimentation traps indicates that both Ni and As continue to be transported to the sediments.

The most active zone of contaminant removal is the surface volume of the pit lake from 0 - 5 m. The reason for this is evident in Plate 1 which illustrates the intense covering of particulate matter recovered in 1999 by the 2m, near-surface sedimentation traps. In the early years, the appearance of the surface traps was quite different (Plate 1 page 47, 1997 report), in that the organic component was dominated by algal growth. In later years this appears to have been replaced with inorganic material.

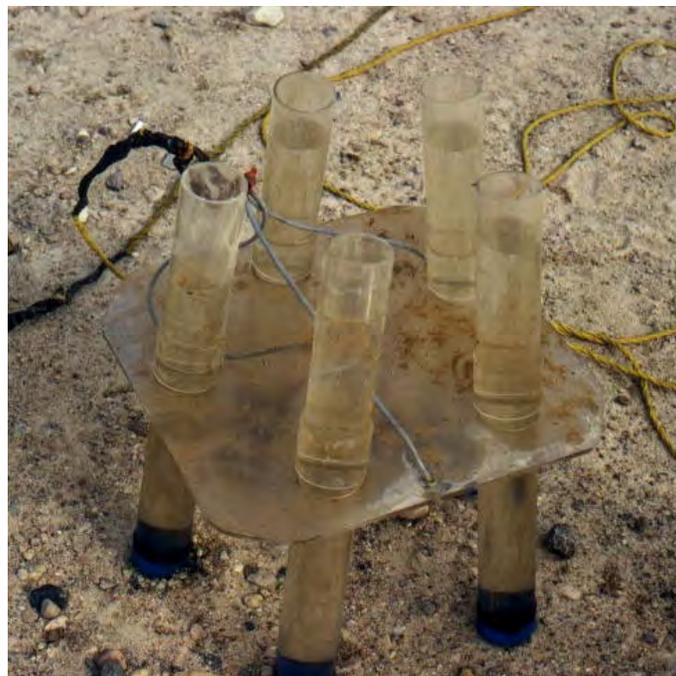
App4-Plate 2: B-Zone sedimentation trap collected at station 6.72 from 12m depth.

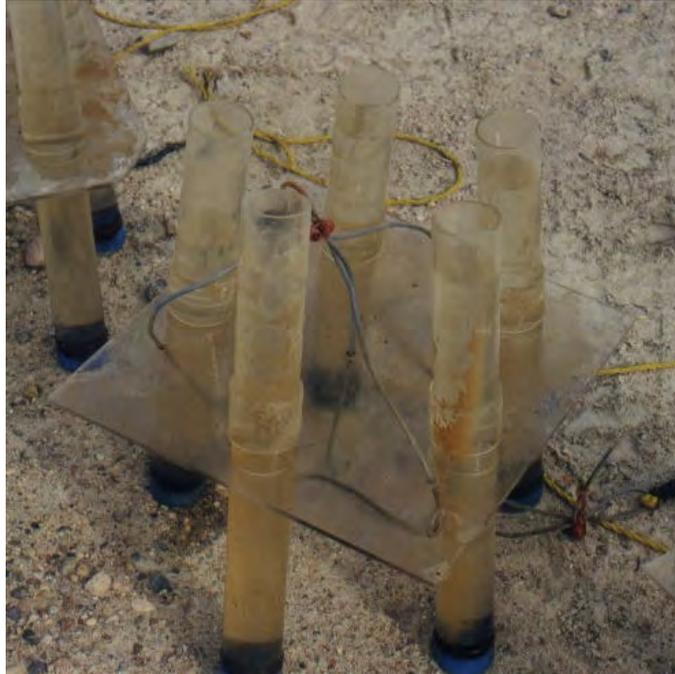
App4-Plate 3: B-Zone sedimentation trap collected at station 6.72 from 22m depth.

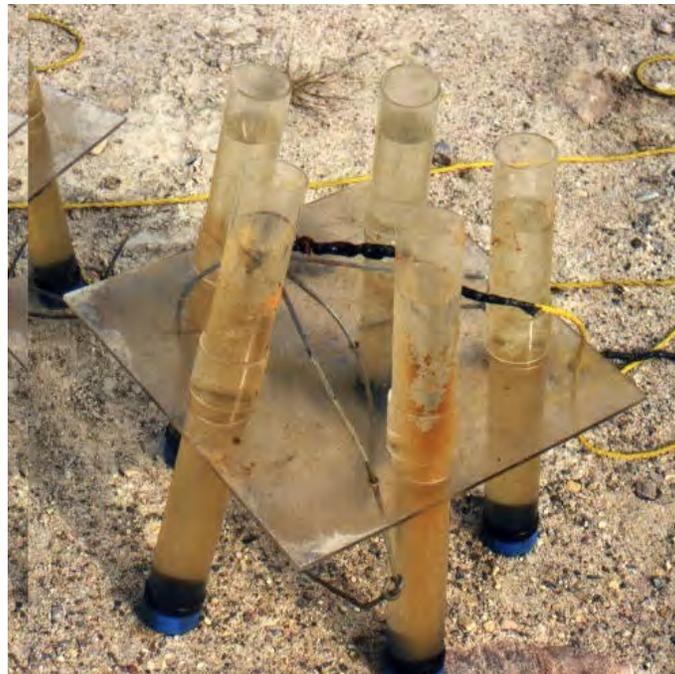
App4-Plate 4: B-Zone sedimentation trap collected at station 6.72 from 32m depth.

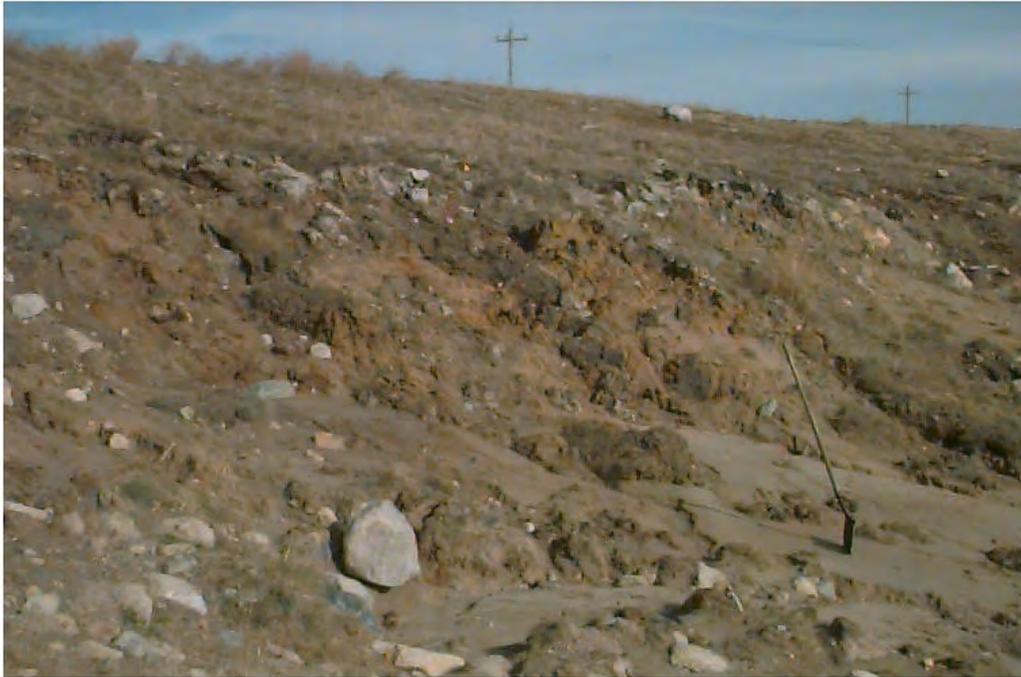
**Photograph 3: Flow slide in soft till material. Location: Area C, Figure 1.**

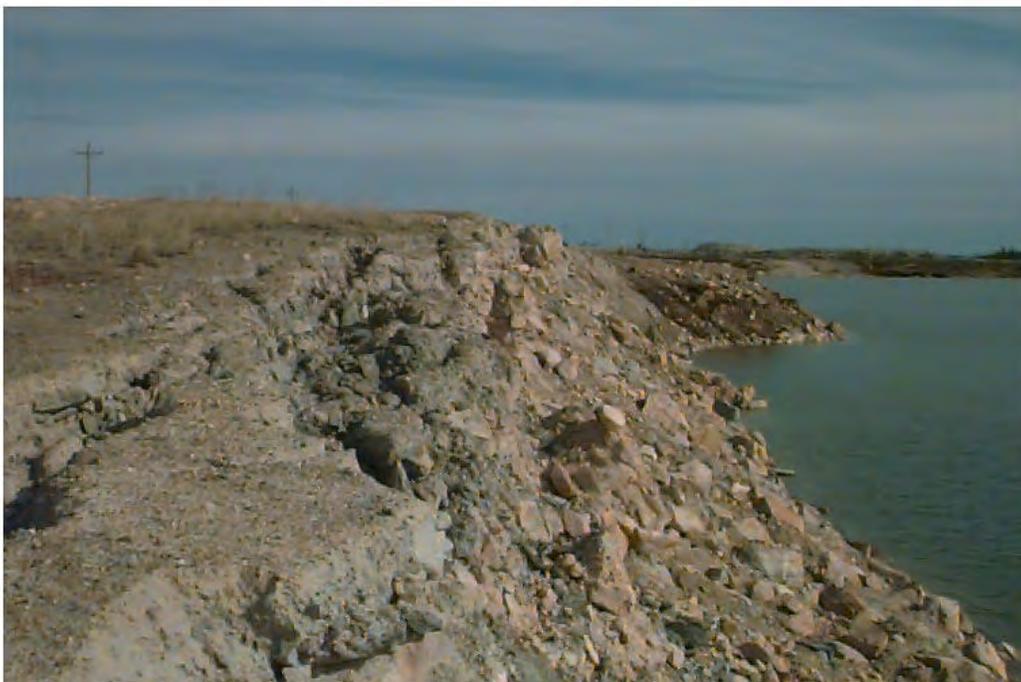
**Photograph 4: Toppling block slope failure in waste rock. Location: D, Figure 1.**

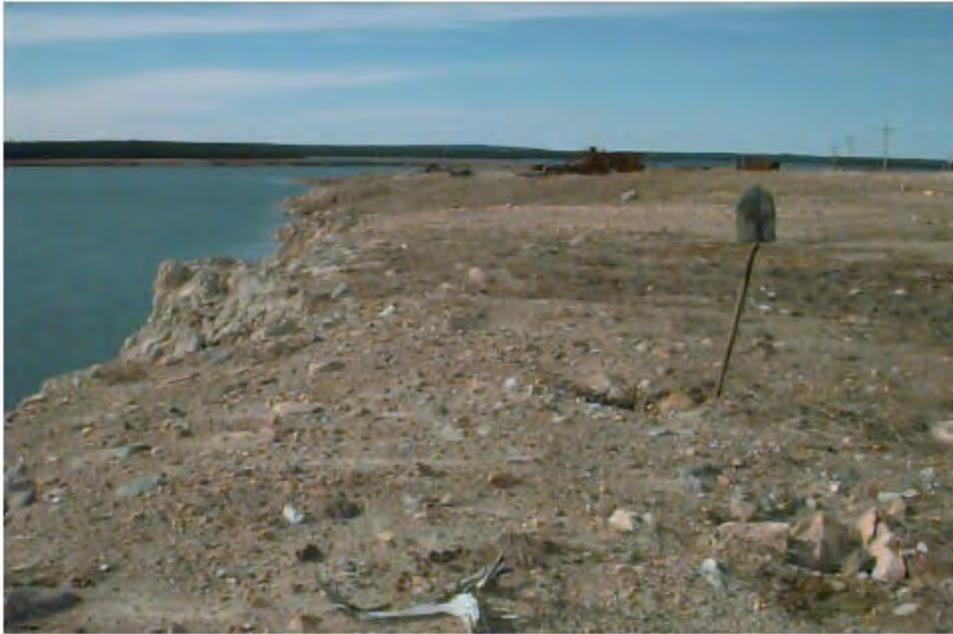
Photograph 5: Upslope location of Photograph 4, showing tension cracks and holes extending several meters behind the slope scarp. Location: Area D, Figure 1

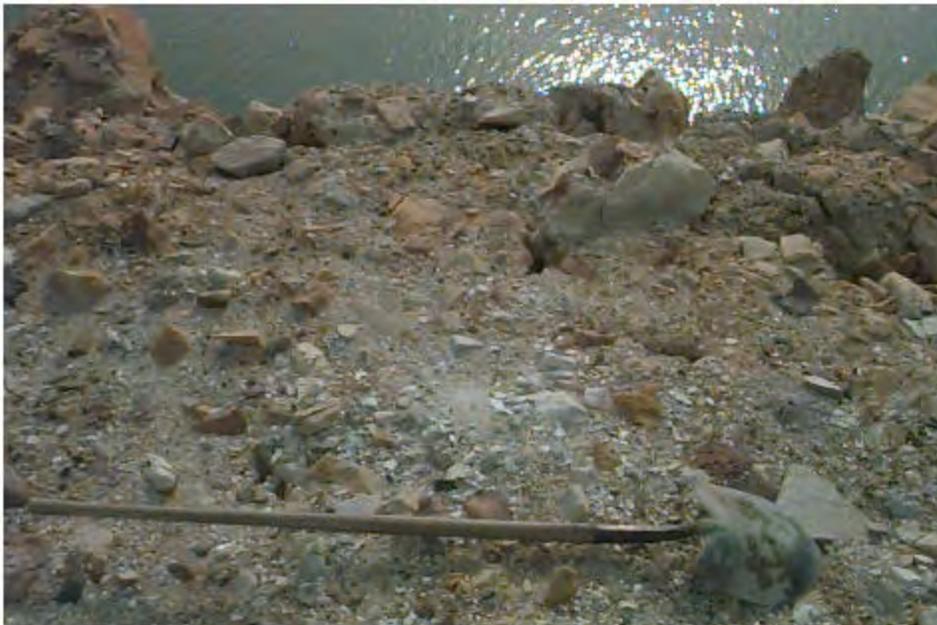
Photograph 6: Close of view material in area D (Figure 1), which is toppling into the pond. Mineralized/altered material is present in the centre of the photograph

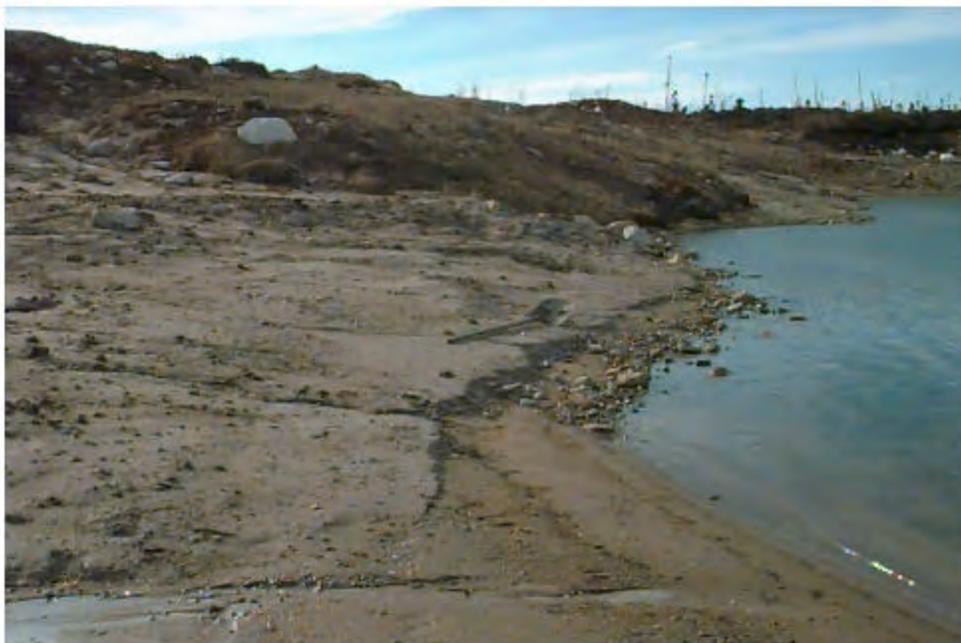
Photograph 7: View of shoreline in Area C (Figure 1), showing eroded beach and small seepage stream entering pond.

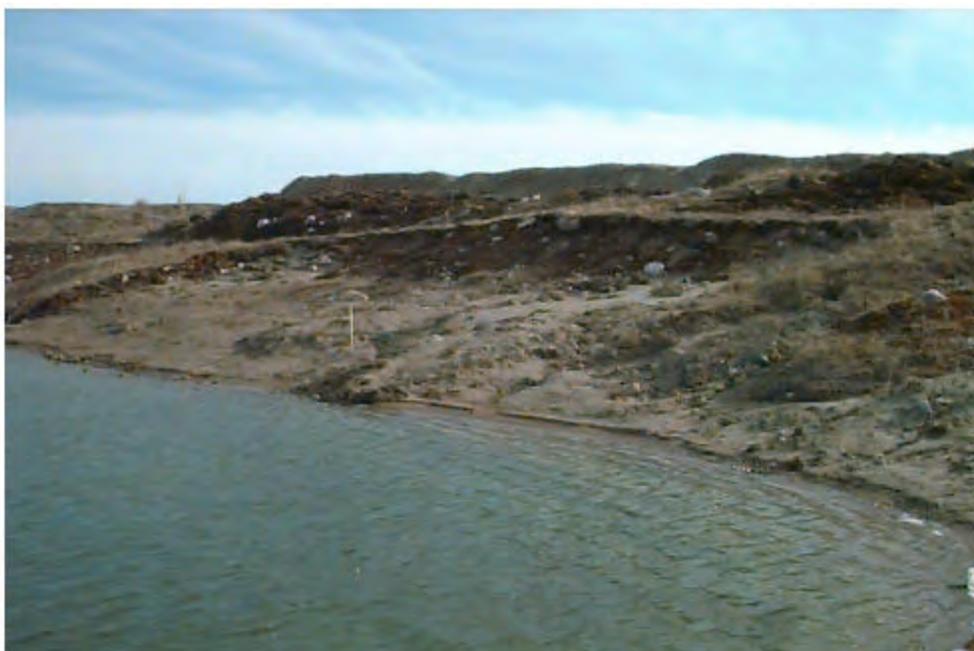
Photograph 8: View of erosion scarp on west side of Area G.

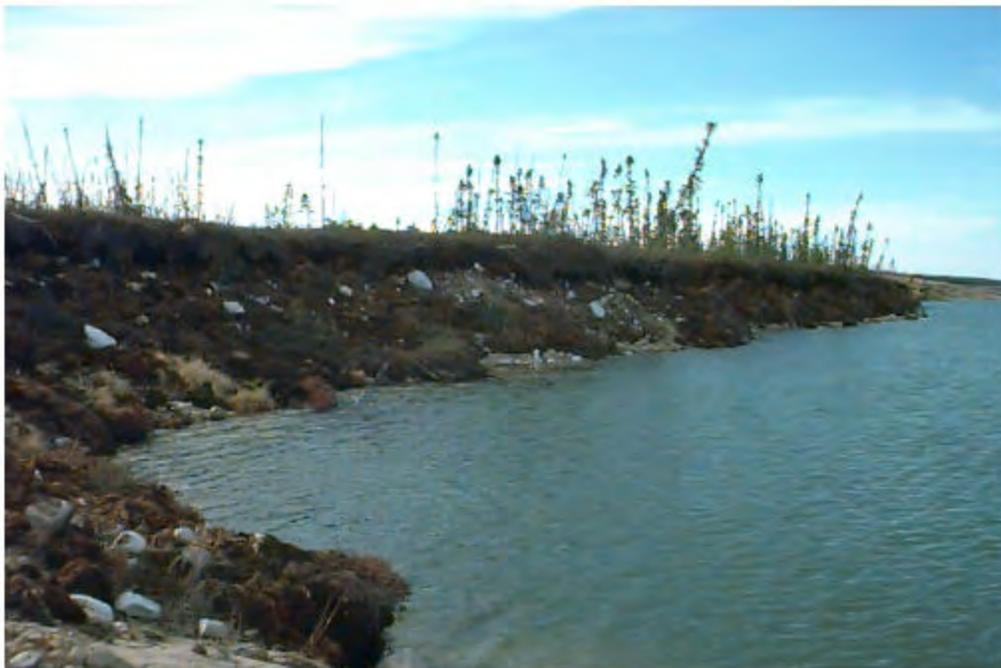
Photograph 9: Slope failure (mass wasting) in natural soil/peat materials in Area H.
