**Development of a Pit Lake  
And  
Fate of Contaminants  
1992-2001**

**July 2002**

## EXECUTIVE SUMMARY

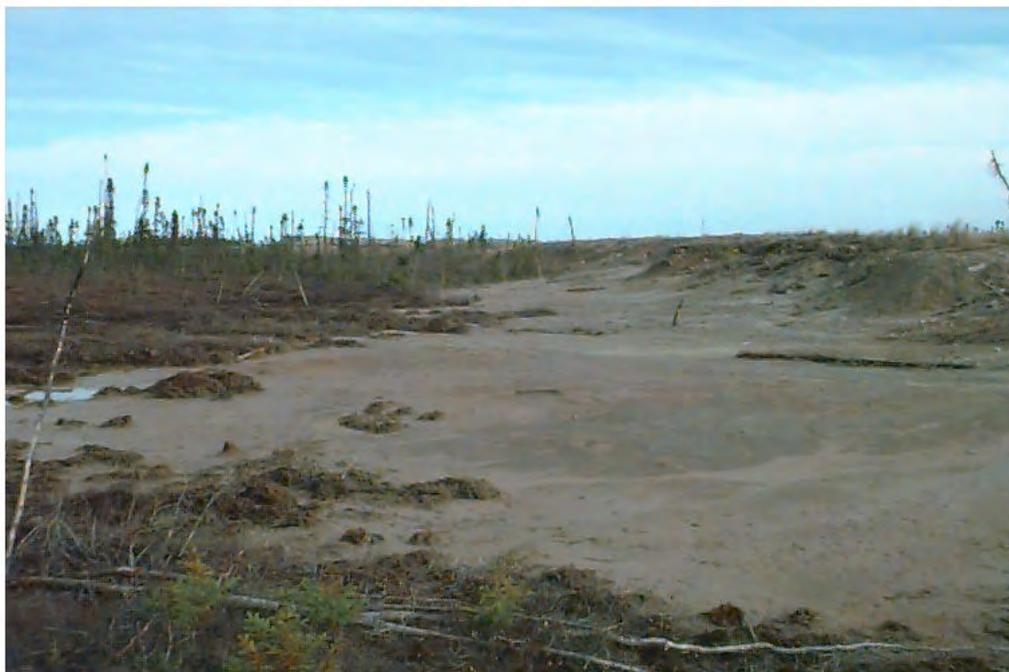
Photograph 10: Alluvial fan extending from perimeter road toward B-Zone pond in Area 1.

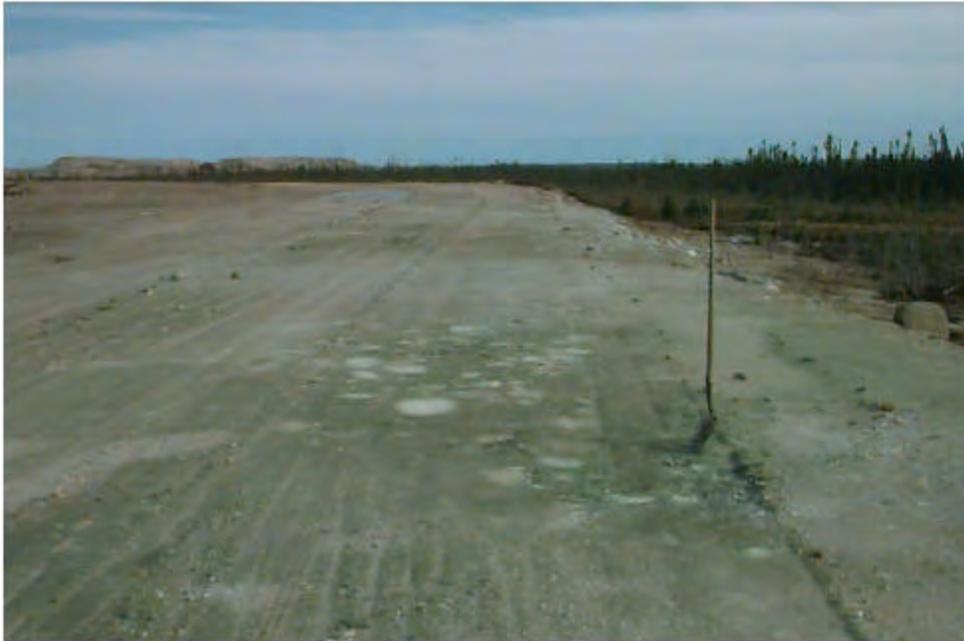
Photograph 11: Looking south along southwest perimeter road in Area K (Figure 1). Note intense blue/green coloration in the foreground.

In 1997, as part of an investigation into above-background gamma radiation, a turquoise or bluish coloration was noted on the surface of a perimeter road southwest of the pit. In 1999, with the recognition that Ni was being renewed in the pit lake, the coloration was again noted, not only on the road but on erosion fans leading from it and on its banks. If these water-soluble, blue evaporites contained nickel, they would explain the seasonal pattern of the Ni concentrations in the pit lake. Generally, throughout the study the lake had been sampled four times a year; the highest concentrations of contaminants were reported in the spring, reductions in June and July and an increase after the heavy rains in August and September and the beginning of the thermocline breakdown.

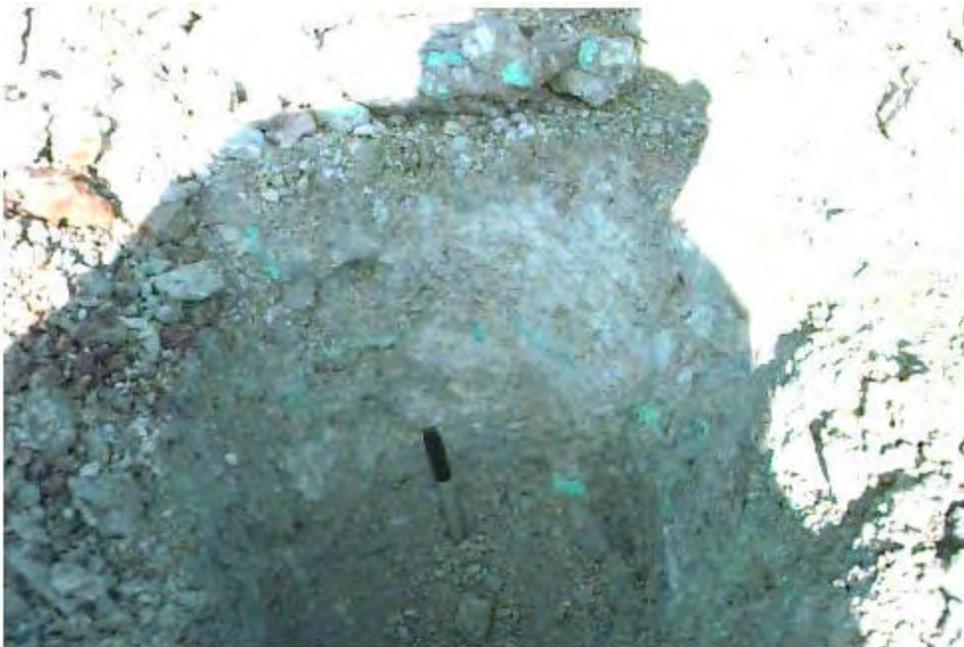
Photograph 12: Close-up of excavation at sample location SWPR1, showing abundance of "Blue Nuggets". (Pen for scale at photo centre.)
