NARRATIVE REPORT

**THE RESTORATION
OF
SOUTH BAY MINE SITE**

July 2003

Boojum Research Limited

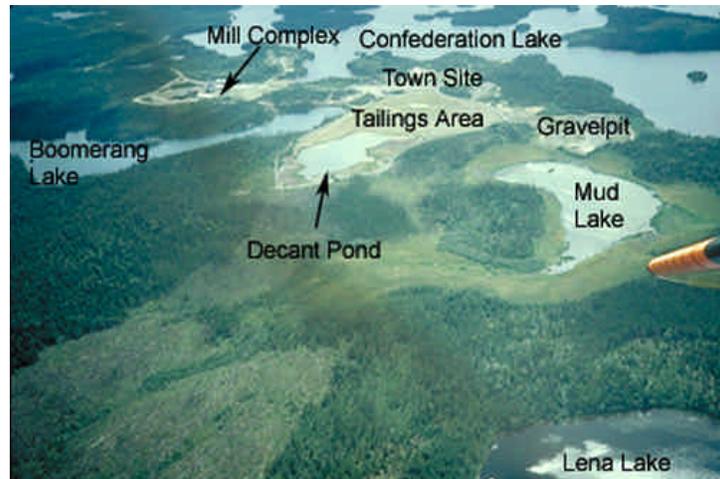
Plate 1: Aerial view of the South Bay min site

The South Bay mine is virtually surrounded either by Confederation Lake, an important sport fishery and tourist destination, or by two tributaries of Confederation Lake, both now included in the South Bay Waste Management Area (SBWMA) (Plate 1). While the pH of those tributary lakes is very low, the enhanced, self-sustaining, biological treatments systems in them have ensured that that the water quality in Confederation Lake has remained within Ontario Water Quality Objectives.

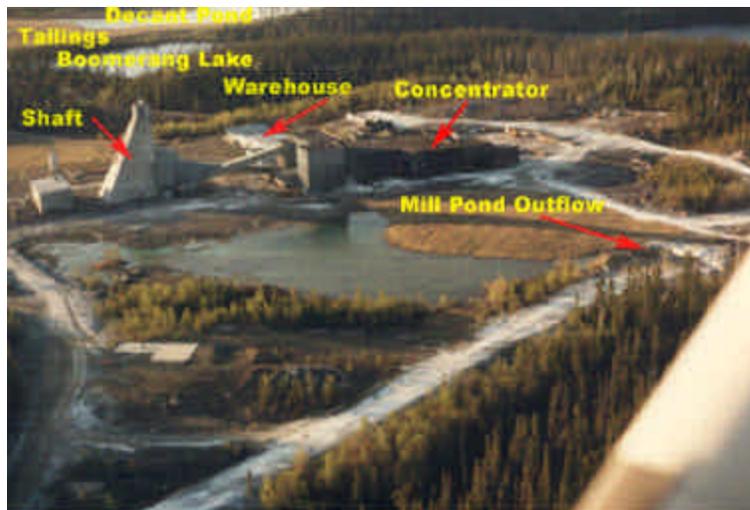
Plate 2: Lime application on the mill site.

The most obvious source of the AMD that was getting into Boomerang Lake was Mill Pond, which drained into the lake by way of a wide, shallow valley. During the life of the mine the pond had been a catchment lagoon for water used in the operations. It continued to receive acidic seepage from a nearby waste rock pile, and run-off from the mine and mill compound which was built upon waste rock, used as fill, and which was further contaminated by concentrates (Plate 2).

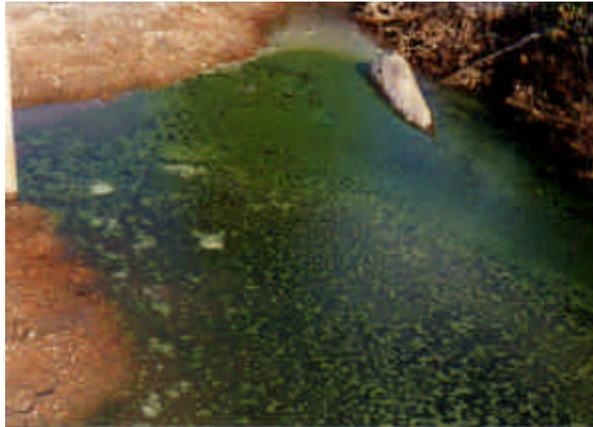
Plate 3: Algae in Mill Pond 1986

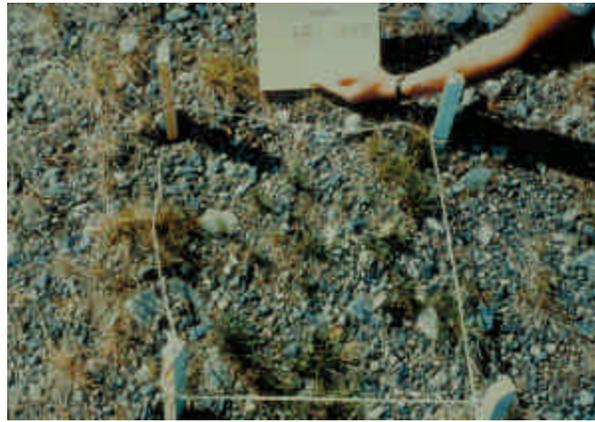
The South Bay tailings basin covers an area of about 25 hectares of which about 5 hectares are underwater. The basin originally held a peat bog that drained into Boomerang Lake. The sides of the basin had been augmented with berms and concrete dams poured into trenches to bedrock, to retain the tailings. When the mine closed, about 300,000 tons of tailings were returned to the mine workings leaving about 785,000 tons in the basin. The dry tailings were covered with gravel to a depth of 30 to 40 cm, hydro mulched and seeded with a mix of birds-foot, trefoil and tall-fescue. Those measures represented the state-of-the-art in mine site remediation in 1981. They were intended primarily to hold down dust although it was also hoped they would exclude moisture and oxygen. Boojum's survey of the tailings vegetation revealed that the introduced species had not done well (Schematic 1). On a more positive note, several indigenous species had invaded the tailings, especially acid-tolerant mosses that had taken hold wherever the tailings retained water after rainfall I (Plate 4).

Plate 4: The sparse grass cover 1986

Boojum recommended that the vegetation on the tailings be left undisturbed so the colonizing species would continue to proliferate. Since little was known about the movement of ground water out of the basin, or anywhere else on the site, the company also recommended that a comprehensive hydro-geological survey be undertaken. Signs that a considerable hydrological head had built up in the tailings was evident in the form of seepages, emerging from the rubble below Dams #1 and #2 and trickling into Boomerang Lake (Plate 5). BP Selco undertook to seal the leaks with grout. (Schematic 2).

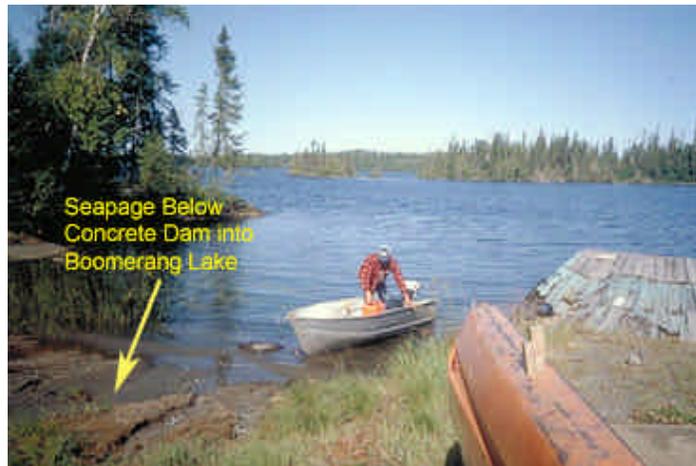
Plate 5: Seepage into Boomerang Lake

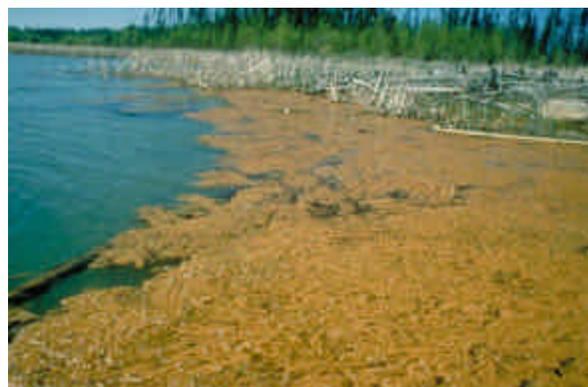
Analysis showed that the dry weight of the algae in the pond consisted of 5.3% zinc, 6.7% iron, 0.6% copper and 0.07% lead. Boojum proposed to stimulate growth in the pond and to further research the growth characteristics of the algal mats to optimize biological polishing.

Plate 6: Decant pond algae mats

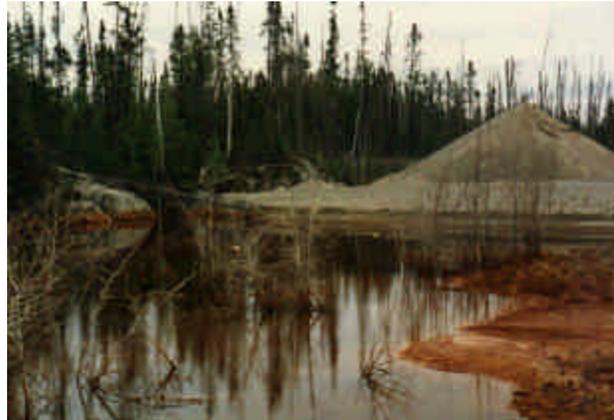
During the life of the mine the 800-meter pipeline, which had carried the tailings slurry from the mill to the tailings basin, had breached leaving two spills large enough to generate an unacceptable level of contaminants. Spill Area #1 contained about 200 m³ of tailings and drained into Boomerang Lake. Spill Area #2 consisted of 709 cubic meters and drained into a large seasonal puddle at the foot of the Backfill Raise (Plate 7). The puddle, in turn, drained into Confederation Lake.

Plate 7: The backfill raise puddle

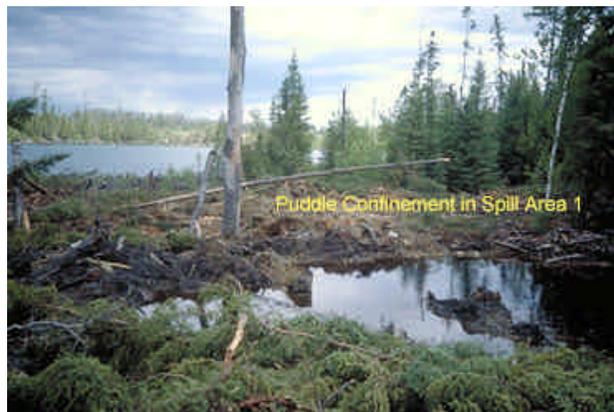
Plate 8: Puddle Confinement in Spill Area 1

Boojum proposed to contour Spill Area #1 into a series of small terraces to retain rainwater until it evaporated and to add organic matter to encourage plant growth (Plate 8).

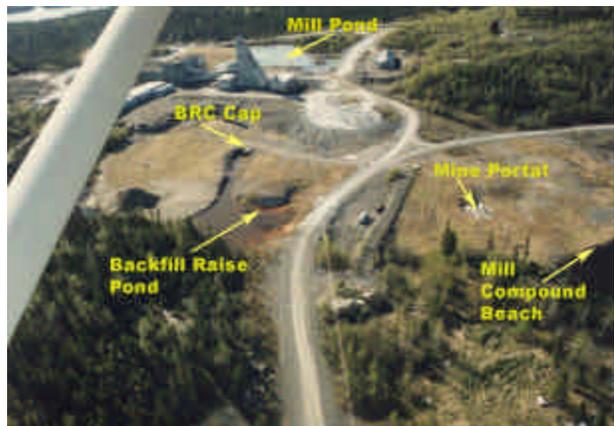
Plate 9: Mill complex overview

The mine complex, a 15-hectare compound, contained the mineshaft housing, mill, concentrator, machine shop, warehouse, and powerhouse all of which were to be demolished within two years. The complex stood on ground that had been leveled in part with acid-generating waste rock (Plate 9). The Mine Shaft, the Backfill Raise and the Portal Raise had been topped with rubble and capped with concrete.

The mine workings were not force-flooded but had been left to fill on their own. A previous study had concluded, erroneously, that since the entrance to the mine and the portal raise were near the top of a local watershed that they would not overflow. Run-off from the concentrate pads and the compound flowed into Mill Pond. Work already begun in the pond would continue.

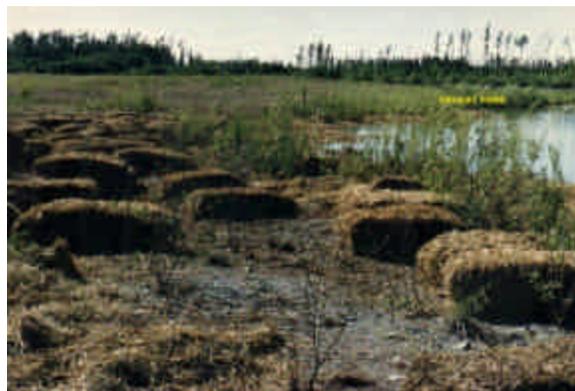
Plate 10: Addition of straw bales to Decant pond beach 1988

The liming of Decant Pond was discontinued in 1986 with a resulting drop in pH. Cattails had colonized the north shore of the pond, where it extended beyond the tailings into muskeg and grew abundantly in the pond shallows. But they were unable to take hold on the south shore, which consisted of exposed tailings. Since the saturated beach seemed to be a major source of the pond's acidification, efforts were made beginning in 1986, to transplant cattails onto the beach, both with a front-end loader and by hand. Cattails are an important component of the ecological toolbox because they extrude polysaccharides through their roots, which stimulate the ARUM process. But they made no headway at all on the beach, which was high in acid and low in nutrients. In 1988 the ARUM effect was induced when 120 bales of straw were scattered on the beach (Plate 10). Analysis of samples that collected and analyzed in 1989 showed that the straw had been colonized by sulphate reducing bacteria.

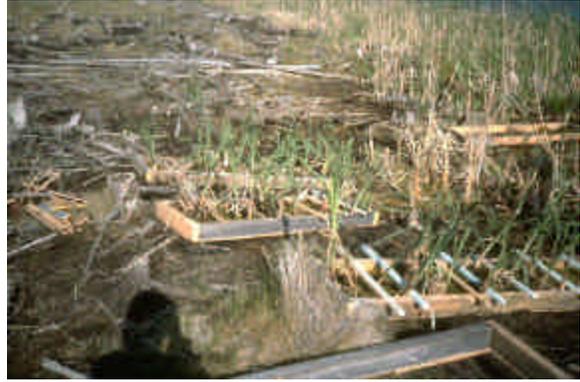
Plate 11: Floating Cattail Raft For Decant Pond

Cattails, planted on rafts and set adrift on the pond were much more successful (Plate 11). Cattails growing under natural conditions will sometimes form floating islands, supported by gases trapped in their root mass. This effectively creates a secondary habitat for sulphate reducers, as well as providing a supply of organic matter that falls to the sediment below. Moreover, they effectively put a lid on the water surface, protecting it from wind-blown agitation, which reduces oxygen levels in the water. Boojum tried to induce the same effect at Decant Pond by setting cattails adrift in wood and wire rafts. The floating cattails thrived... at least until the winter of 1990 when muskrats moved into the pond and devoured their roots. The presence of the muskrats was at least testimony to the fact that Decant was returning to a natural state.

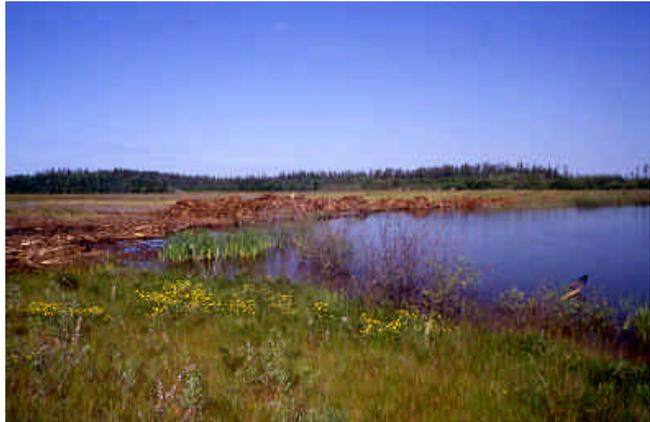
Plate 12: Forestry wood waste addition in 1992 to Decant pond beach.

The pH of the pond was also affected by heavy rainfall in 1991 and 1992, which created acidic puddles on the tailings and which eventually found their way into the pond. Moreover, the intermittent flooding of the tailings beach accelerated the precipitation of iron, which built up dramatically on the straw and reduced the effects of ARUM. The straw was augmented, in July 1992, with 30 truck loads of decomposed bark, forestry wastes, after laboratory experiments confirmed that it would stimulate ARUM (Plate 12). This resulted in an almost immediate increase in pH.

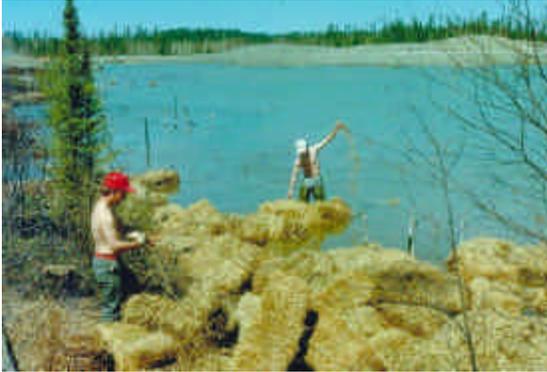
Plate 13: Summer students adding straw to Mill Pond 1986.

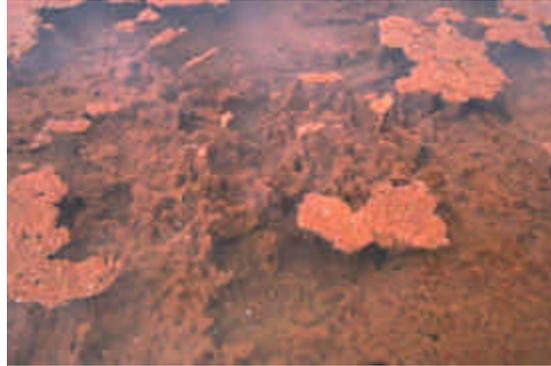
Plate 14: Algae blooming in Mill Pond 1990

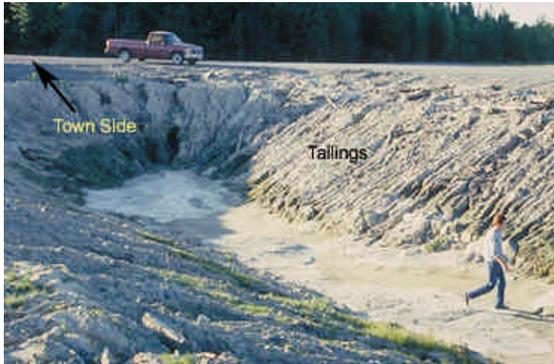
Plate 15: Ground Water Diversion Ditch at an early stage of construction

Early in 1987, to capture the southwest plume, work crews excavated an interceptor ditch that extended in a broad arc from the southwest corner of the tailings basin back to Boomerang Lake. The Groundwater Diversion Ditch was about 500 meters long and about three metres deep, with a bottom elevation of 1,365 feet above sea level (Plates 15 and 16).

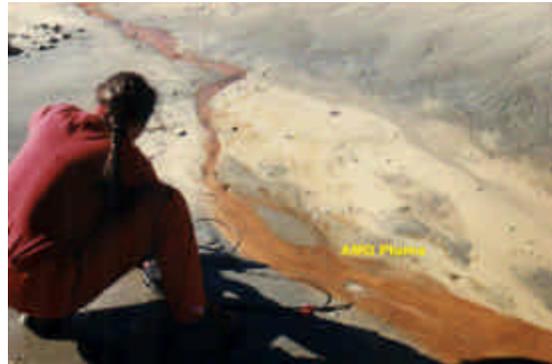
Plate 16: The ground water plume in the Diversion Ditch

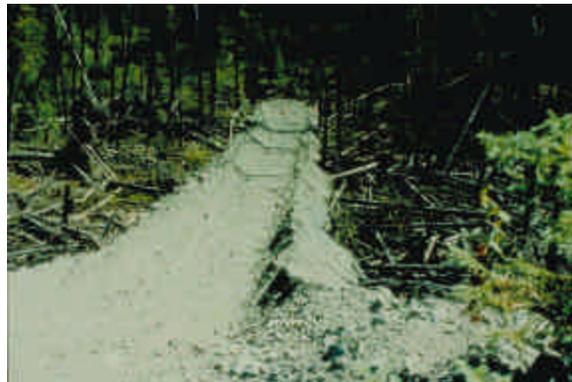
Plate 17: Dave's dam and lower dam 1987

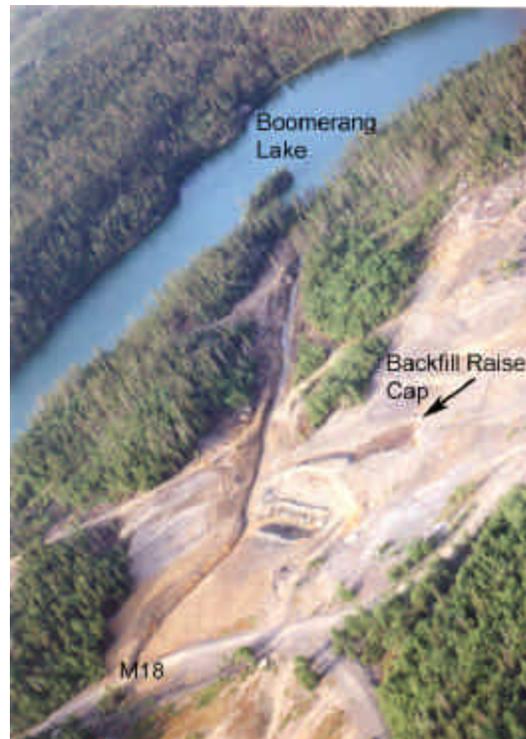
Plate 18: Extending and deepening the Backfill Raise ditch

The Backfill Raise Diversion Ditch was extended and deepened which successfully intercepted the plume and carried it to Boomerang Lake (Plate 18). Much of the ditch was dug through waste rock, used as fill, and through Tailings Spill #2 so the sides were particularly inhospitable to vegetation. In the summer of 2000, 4 tonnes of wood ash, another waste product of the forestry industry, were dispersed onto the slopes of the ditch, which raised the pH of the waste materials and provided nutrients for plant growth. By the end of the summer, a thick carpet of moss had begun to cover the ditch, reducing infiltration into the waste rock.

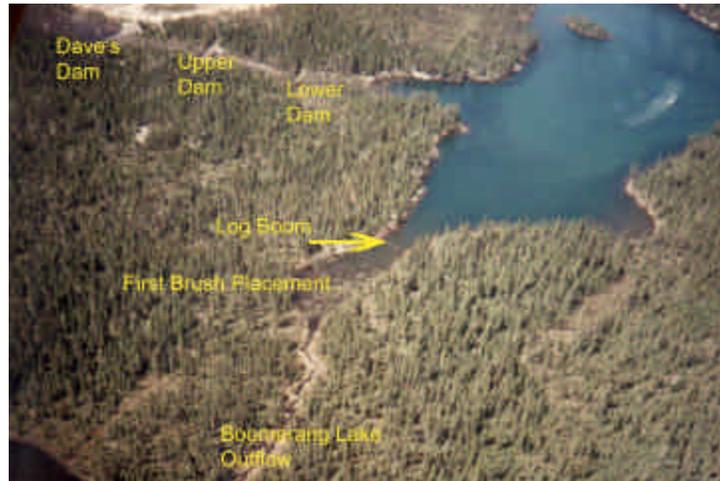
Plate 19: Log Booms in Boomerang Lake Outflow

The diversion of more contaminants into Boomerang added urgency to the search for ways to immobilize them. In 1987, Boojum staff dropped 600 cuttings, mostly spruce trees and roadside brush into the shallow waters along the edges of the lake or within logs booms anchored wherever influxes delivered contaminants (Plate 19).

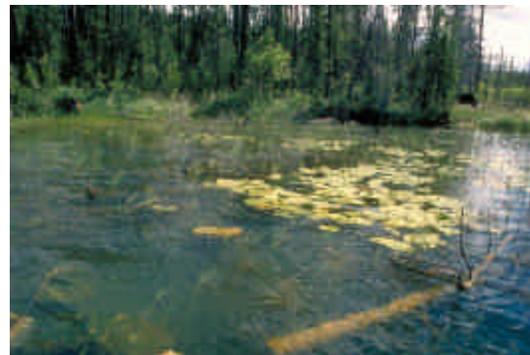
Plate 20: Boomerang Lake Outflow, moss and brush cuttings 1991.

Working at another mine site, Kalin had shown that aquatic mosses stabilize lake sediments and capture falling debris by growing up, around and through it, adsorb zinc and iron precipitates and consume oxygen at the lake bottom, further inhibiting activity of acidophilic bacteria. Since the bottom of Boomerang was almost completely devoid of vegetation Boojum technicians gathered 200 bags of moss, collected in the run-off from the tailings spill and in similarly acidic waters in Elliot Lake. These were anchored to the bottom of Boomerang, beneath the log booms filled with brush. Water with a low pH does not draw carbon from the atmosphere which is why phytoplankton will not grow well in acidic lakes. But aquatic moss extracts inorganic carbon from the degradation of organic material in the sediment. The moss in Boomerang thrived. (Plate 20).

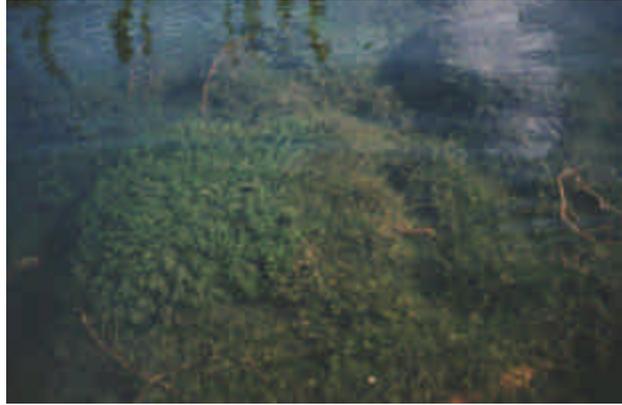
Plate 21: Moss growth Boomerang Lake 2000.

Wherever phosphate was used, the results were encouraging (Plate 21). Water quality in Boomerang was immediately improved. It was estimated that the 9 tonnes of phosphates added to Boomerang had taken 330 kg of zinc out of solution, 1.35 tonnes of iron and 276

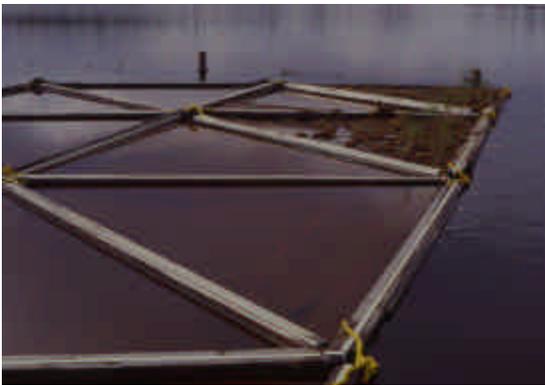
Plate 22: Arum cover installation in Mud Lake

Mud Lake was incorporated into the SBWMA and efforts were made to stimulate ARUM in it. Potato wastes were scattered on the sediments in the discharge zone of the groundwater, and floating cattails were introduced. Within a year, however, the cattails failed, because the floating structures that supported them became saturated with iron and sank (Plate 22 and Plate 23). In 1997, 60 tonnes of phosphate were added to precipitate iron from the lake water onto the sediment.

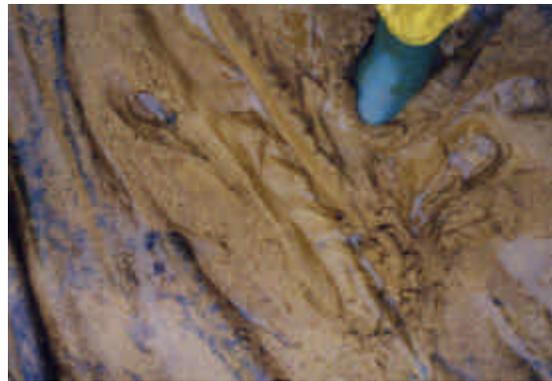
Plate 23: Iron precipitate on the Arum cover

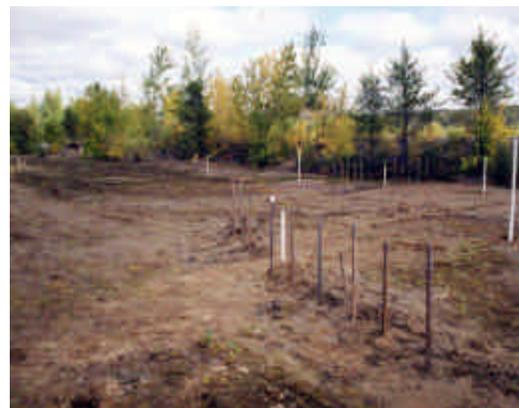
Plate 24: Setup of 1st urea experiment

Field tests were conducted, just outside the tailings, in contaminated ground water trapped on a layer of clay in a sandy overburden (Plate 24). In 1998, urea was added at a depth of one-meter in the sand. Urea is converted by ureolytic bacteria to ammonia, which raises pH and leads to the precipitation of metals below ground; the degradation of sugar assists in the formation of metal carbonates and, of course, stimulates the sulphate reducers. Within a year, the urea reduced zinc from 1000 to 200 mg/l but no further. The addition of sugar, a year later, resulted in a further reduction virtually to zero (Figure 3). and an increase in pH from 3.5 to 7.

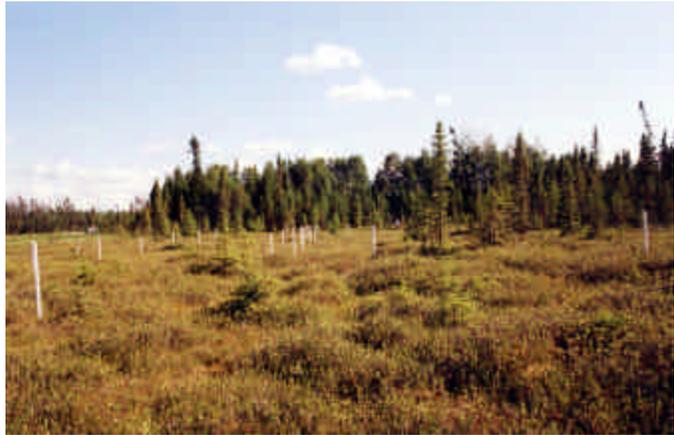
Plate 25: Monitoring wells for in-situ ARUM

Based on those results, along with the results of laboratory work at University of Toronto and geochemical simulations of ureolytic bacteria, a large pilot test area was selected on the shores of Mud Lake (Plate 25). In that test, begun in 2000, ground water is drawn from the Kalin Canyon plume from a depth of 16 m, enriched with urea and sugar and re-injected at 6 m with a passive drip system as shown in its initial stages in Plate 26 and Schematic 3. It is carried from there to Mud Lake. Preliminary data suggests that alkalinity is being generated in the plume. The study continues.

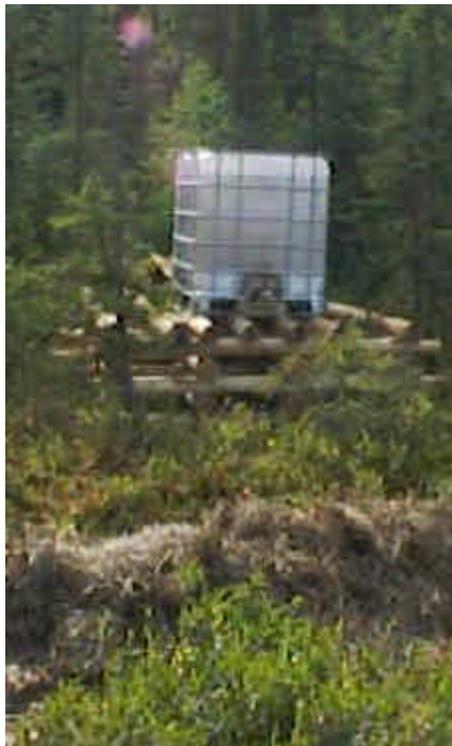
Plate 26: Setup of feeder tank to drip system

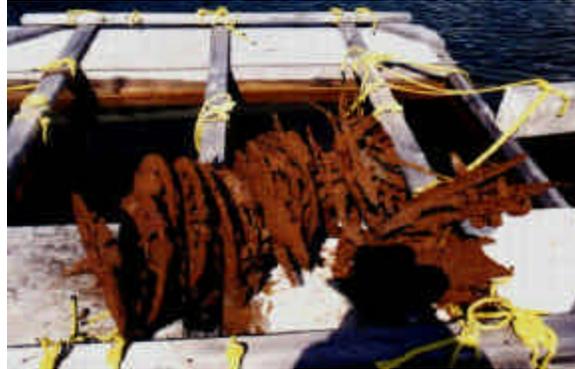
Plate 27: Magnesium scrap metal pieces in Boomerang lake

. Experiments are also ongoing into ways in which the pH in Boomerang Lake can be increased through the use of metallic magnesium, a process known as Passive Electrochemical Treatment (PET) (Plate 27). Submerged in acid waters, magnesium consumes hydrogen ions, thereby increasing pH. Tests in the effluents from the Backfill Raise, in the seeps on the Mill Site and in Boomerang Lake have been promising. A full application to raise the pH to a target level is under consideration.
