**IDENTIFICATION OF POTENTIAL ENVIRONMENTAL
PROBLEMS AT PORT RADIUM.**

FIELD REPORT:

In search of uranium mill tailings.

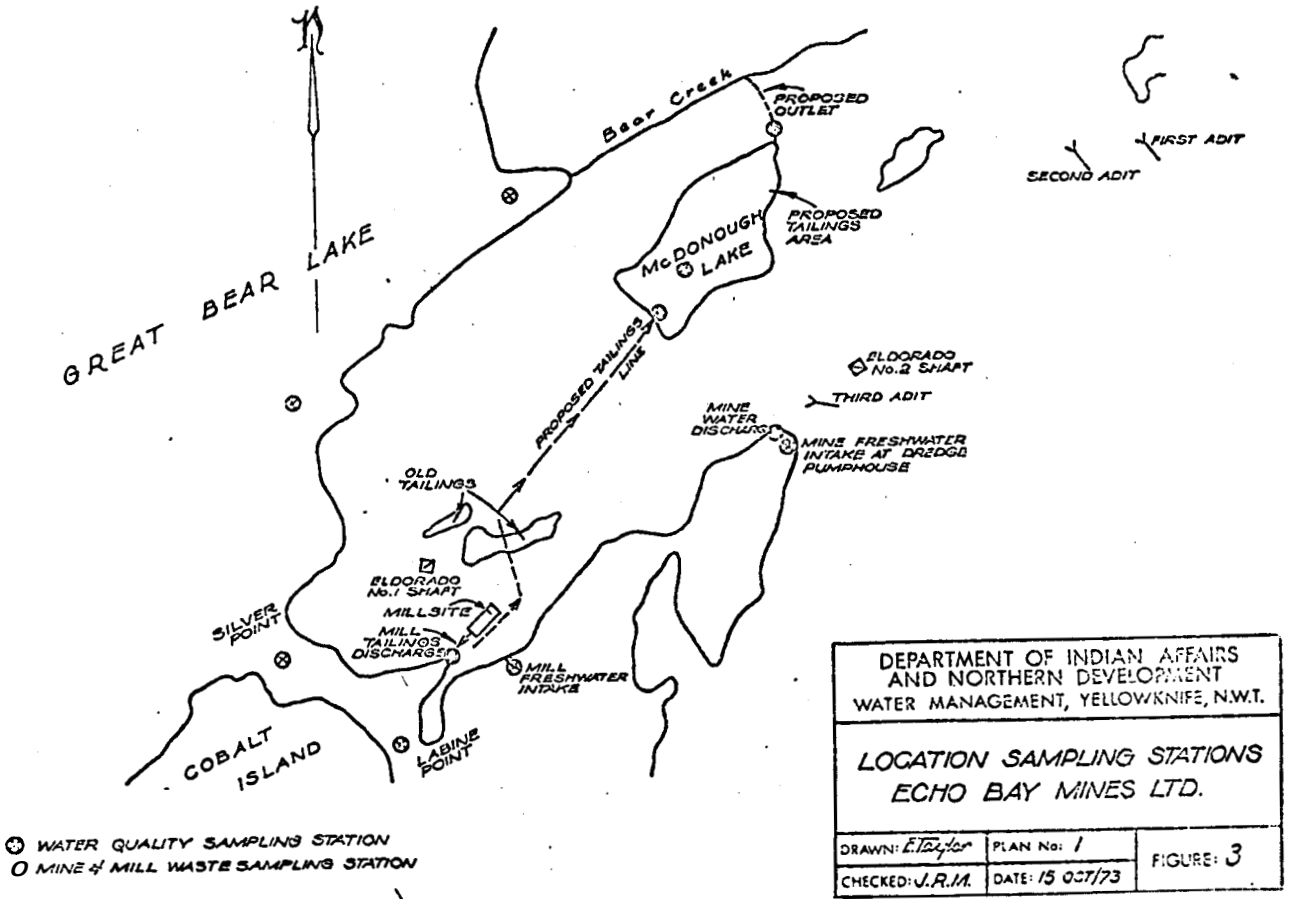
Figure 3: Old tailings reference. Source: Consolidated DOE-DIAND Paper, November 15, 1973.

1. **Former Radium Lake (Site 7):** Virtually all maps inspected in government files and site plans of the Port Radium peninsula make reference to two small areas behind the old town-site which are labelled 'old tailings', as for example in Figure 3. One of these areas was easily identified on site. It is referred to in this report as Murphy Lake. The larger more elongated area, however, is more difficult to identify. The former Radium Lake is covered with a solid layer of overburden and possibly some waste rock. It served many purposes including space for the curling rink, a walk-in cooler, a road to Shaft # 1 and presently the cookhouse and the trailers. This area was also used as an ore stock pile area and as storage space for heavy machinery and ultimately as a general parking lot. As a consequence, at present this tailings area is covered and well compacted. It is hardly an old uranium mill tailings site, but rather a flat area, which is rare on the Port Radium peninsula. The ditch alongside of the road when closely inspected, reveals that at one point this area had possibly something to do with tailings. Material resembling fine tailings mixed with sand and peat-like organics and smelling of diesel oil has a pH of 7.1 and an electrical conductivity of 310 to 480 $\mu\text{mhos/cm}$. Overburden from this area has a pH of 8.0 and an electrical conductivity of 240 to 500 $\mu\text{mhos/cm}$, indeed not different from the 'junk' in the wet ditch. These 'old tailings' can be considered history, as neither silver nor uranium mill tailings are presently exposed.

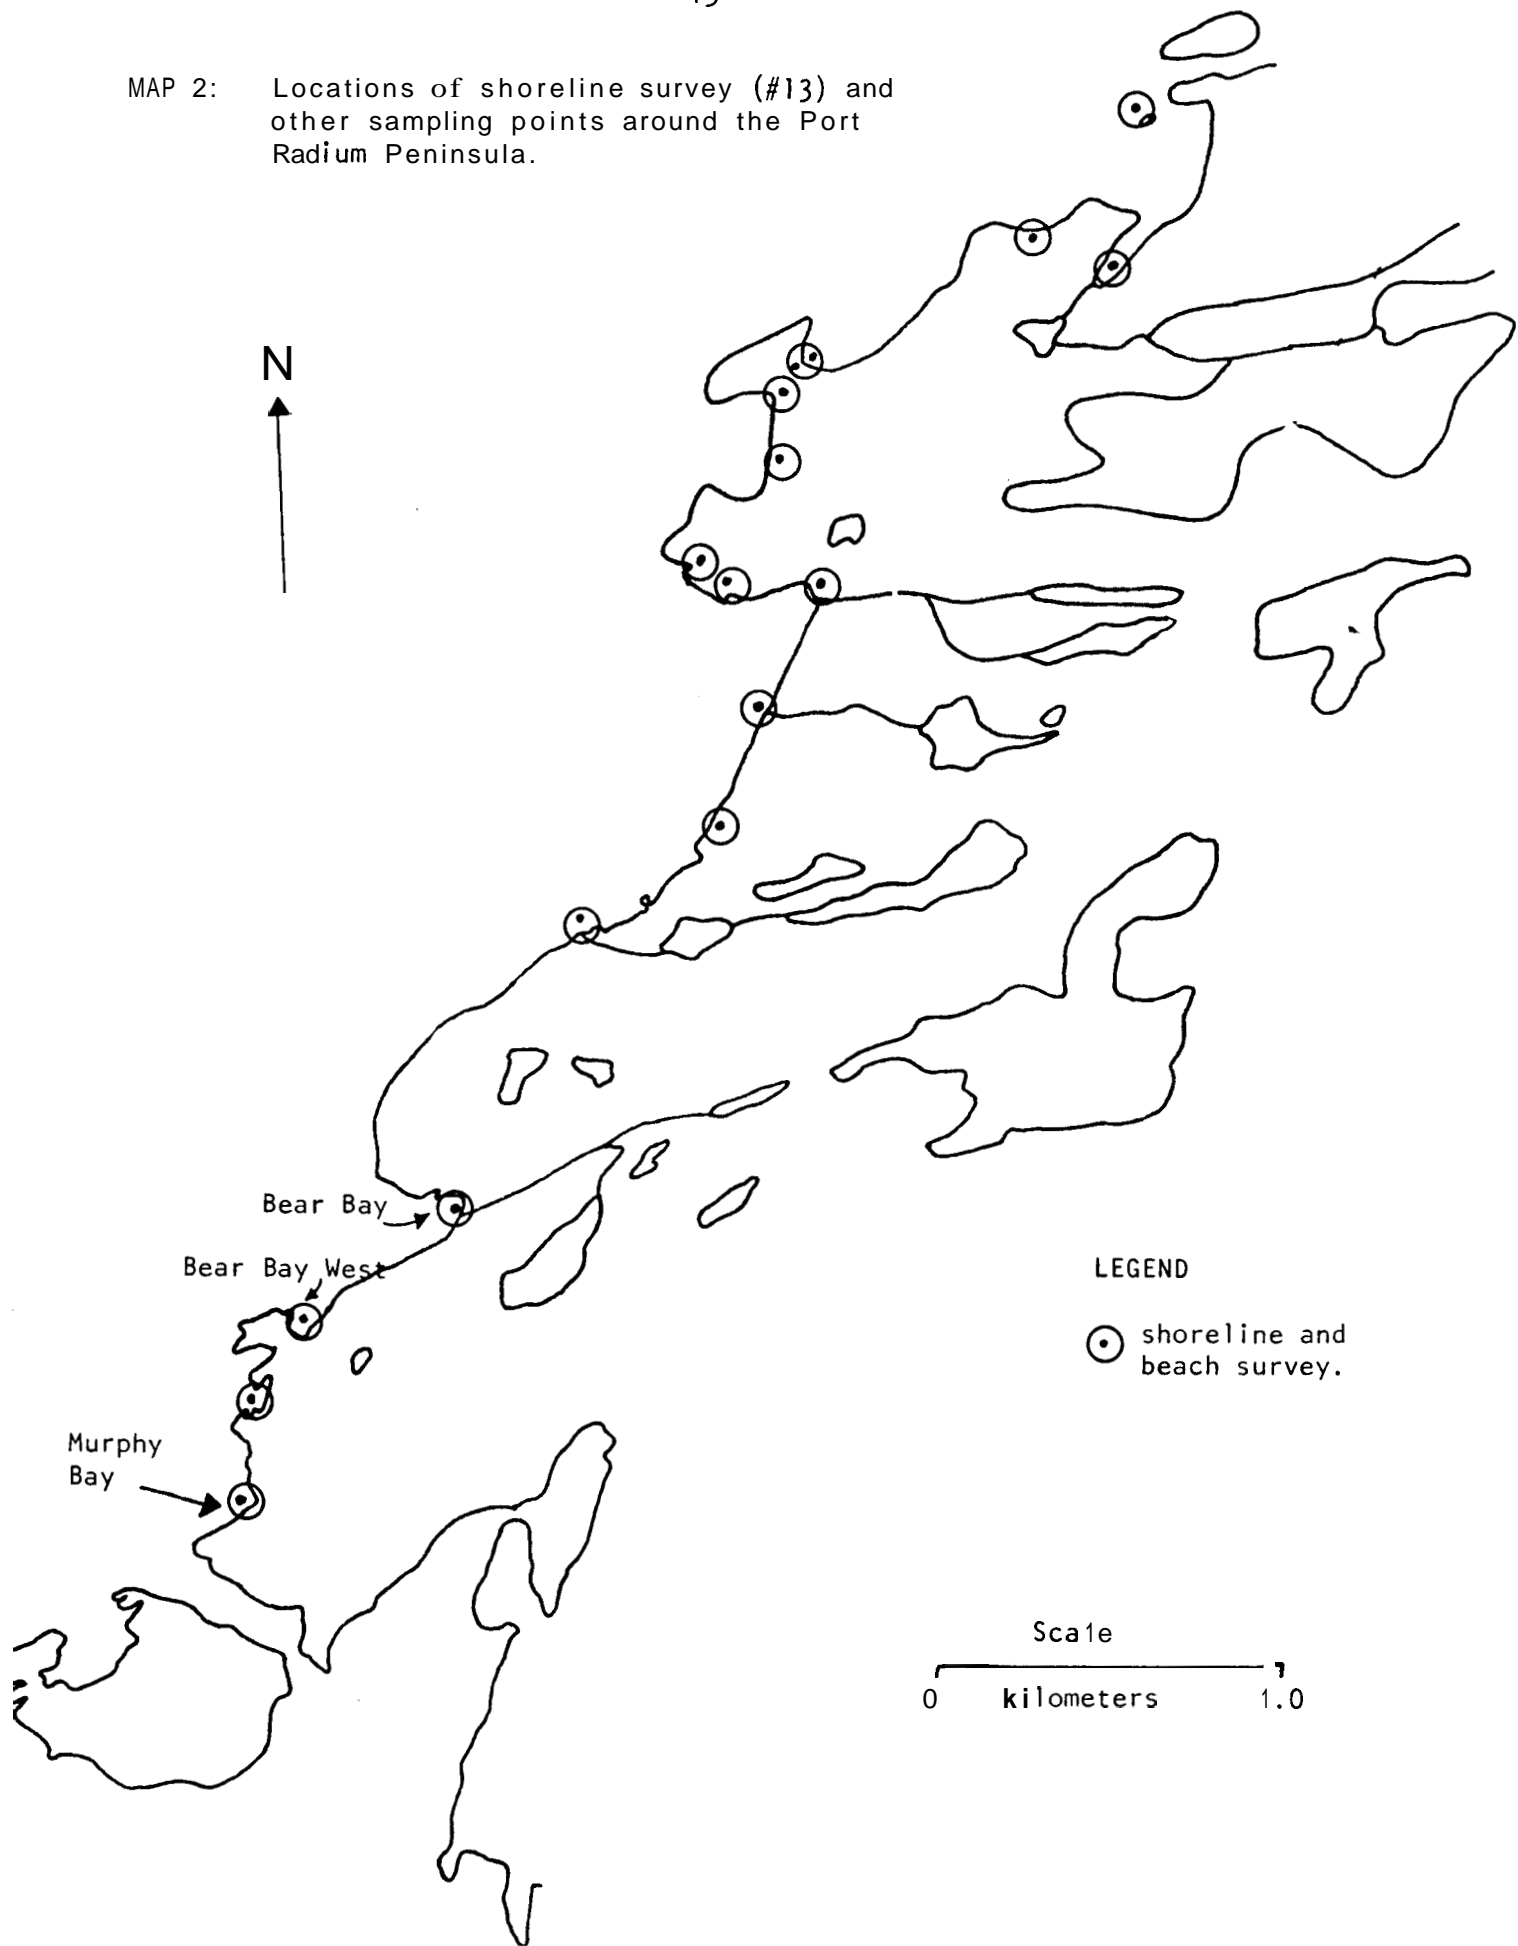
MAP 2: Locations of shoreline survey (#13) and other sampling points around the Port Radium Peninsula.

2. Shoreline survey (Site 13): The northern shores of the peninsula were searched to find evidence of a similar periphytic bloom compared to that of Bear Bay on beaches not affected by tailings discharge. On Map 2 the locations investigated are indicated by circles. Material was collected where possible. In most locations only small pockets of attached algae could be detected. Slight variations in pH and conductivity can be observed around the southern part of the shores (Figure 5), discussed later with the tailings discharges on the peninsula. Only on the West Bear Bay a somewhat larger periphyton population was observed. However, it was not at all comparable to the extent of the bloom on Bear Bay beach. The pH and the electrical conductivity of the water was consistent on all sites at 0.2 and 120 $\mu\text{mhos/cm}$, respectively. The shoreline survey led to the conclusion that the periphyton bloom observed on the Bear Bay beach is unique and likely related to the discharge from Garbage Creek and Garbage Lake.
