**Water Characteristics of  
The Upper Blackfoot River  
with  
Inactive Mine Workings**

**MIKE HORSE, ANACONDA AND CARBONATE**

**Margarete Kalin**

**ASARCO (NORTHWESTERN EXPLORATION DIVISION)**

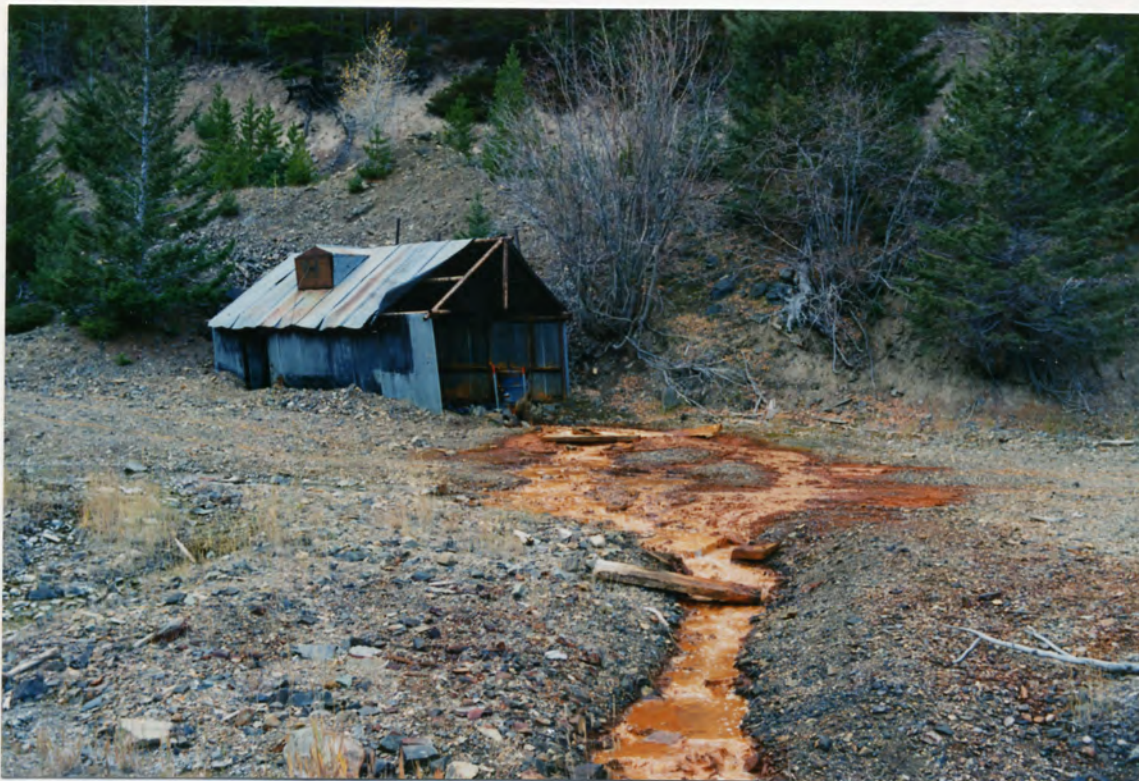
**Plate 1:** Mike Horse portal showing AMD seepage and precipitate  
October 23, 1989 (Station 6, Map 1)

This investigation focused on the effluent emerging from the three latter workings flowing into the Upper Blackfoot river. Starting at the Mike Horse portal (Plate 1), the effluent joins Mike Horse creek which originates above the portal and runs along the valley where it is joined by a spring about 600 feet below the Mike Horse portal. As the creek runs further along past the base of the reclaimed tailings pond, a seepage stream from the tailings pond (Plate 2) enters Mike Horse creek. After this point, the creek is referred to as Beartrap creek.

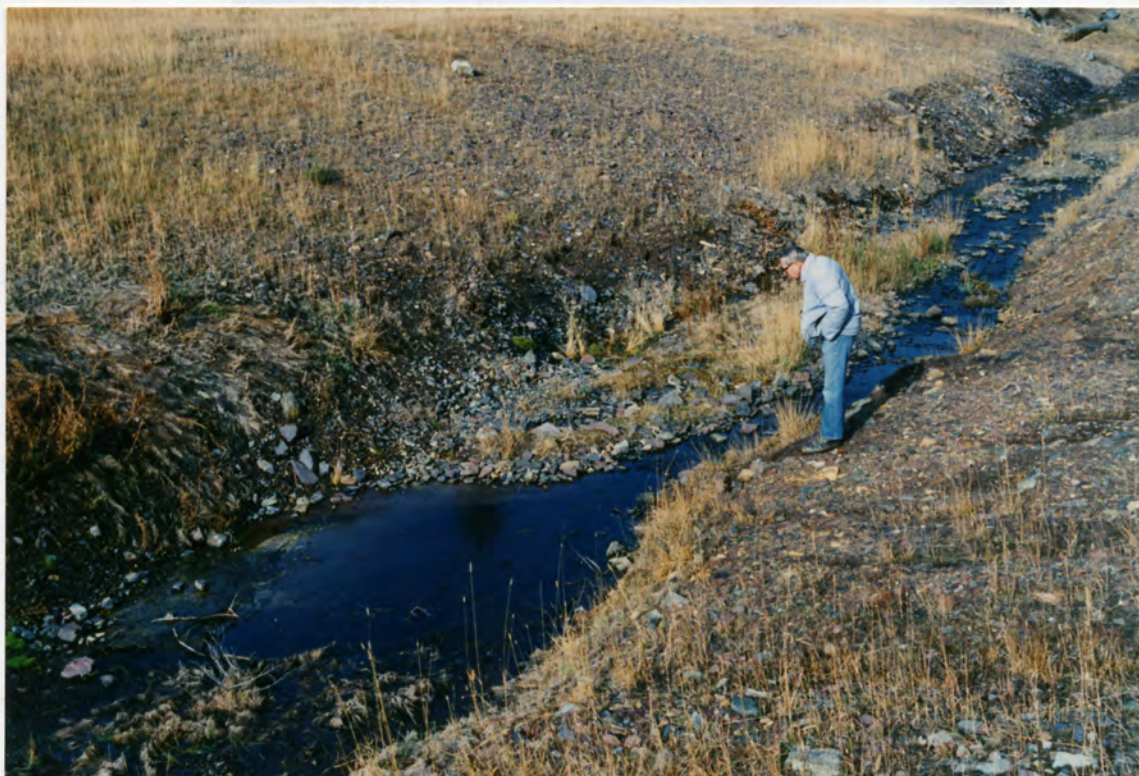
**Plate 2:** Seepage from reclaimed tailings ponds (Station 3, Map 1)  
October 23, 1989 (Station 3, Map 1)

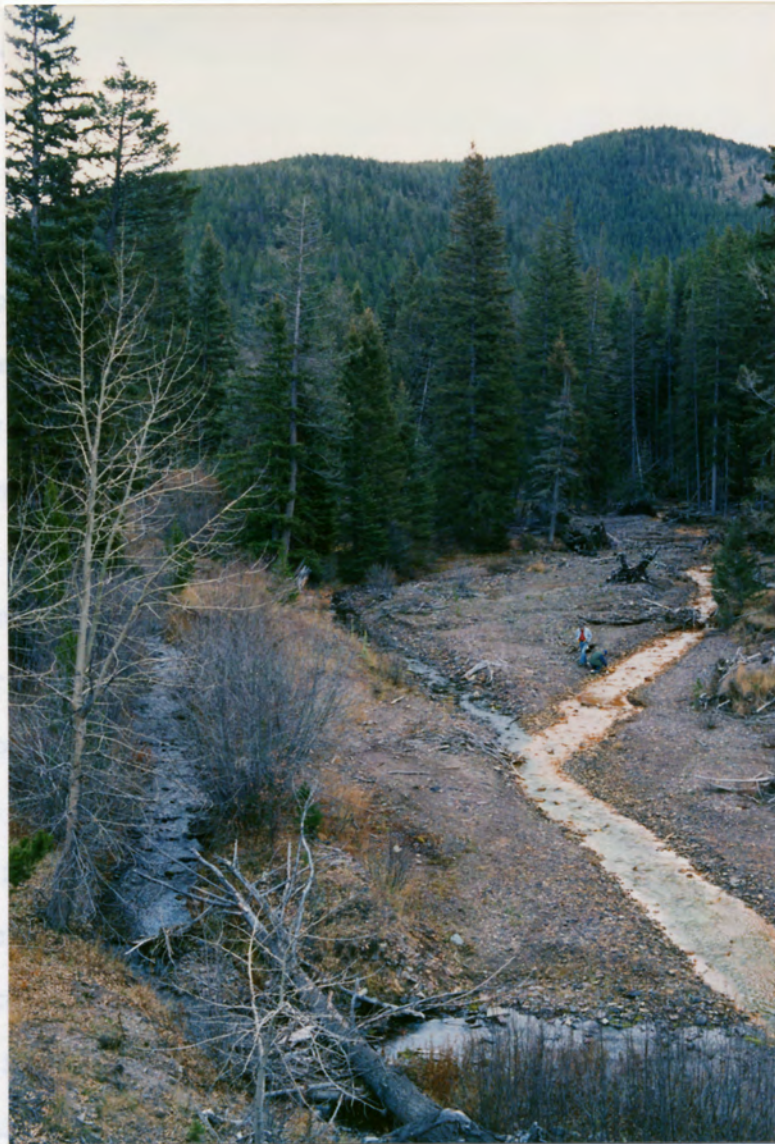
**Plate 3:** The junction of Anaconda creek (clear) and Beartrap creek with precipitate. October 23, 1989 (Stations 10 and 12, Map 2)

After about half a mile below the Mike Horse portal, Beartrap creek is joined by Anaconda creek, just slightly above the Anaconda tailings dump (Plate 3). At this point in the drainage basin, Beartrap creek becomes the headwaters of Bearfoot river which, prior to reaching Highway 200, is joined by the drainage of one unnamed gulch, Paymaster gulch from the east side, and Shave gulch and Pass creek from the west side of the valley.

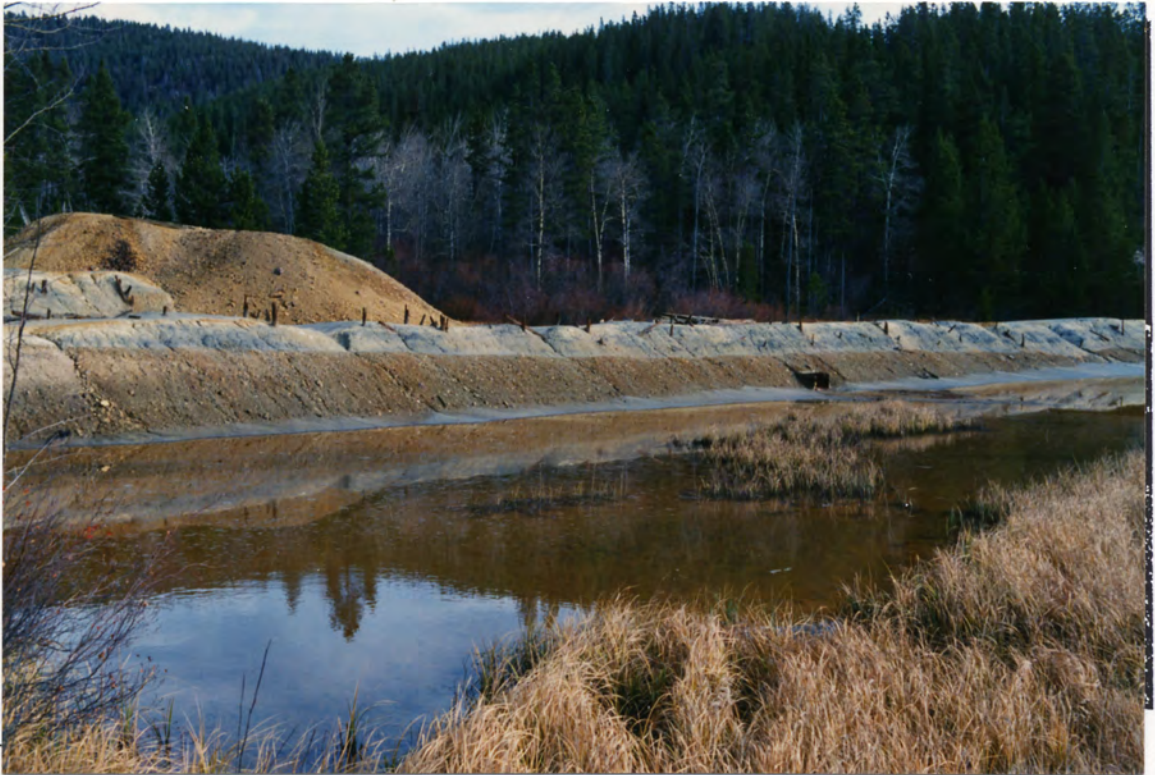
Plate 5: Carbonate mine tailings pond, view from highway 200, October 23, 1989 (Station 1, Map 1)

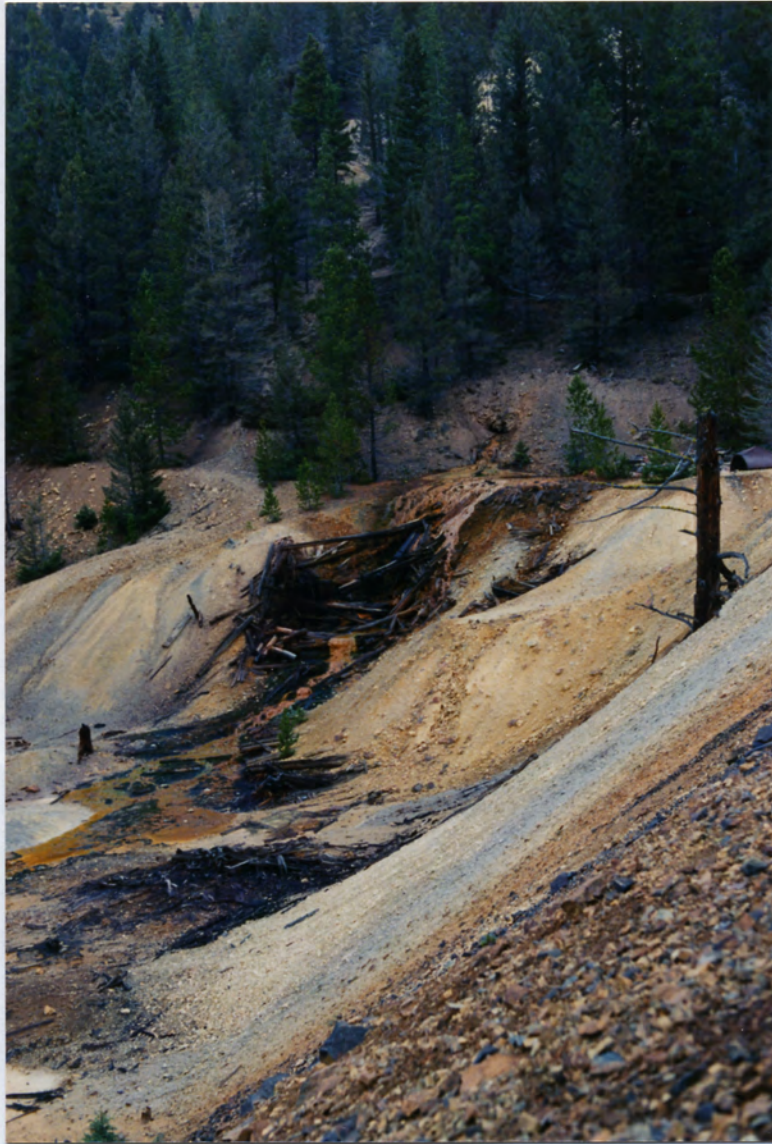
**Plate 7:** View of the Anaconda seepage and old portal from natural seepage retention area. October 23, 1989

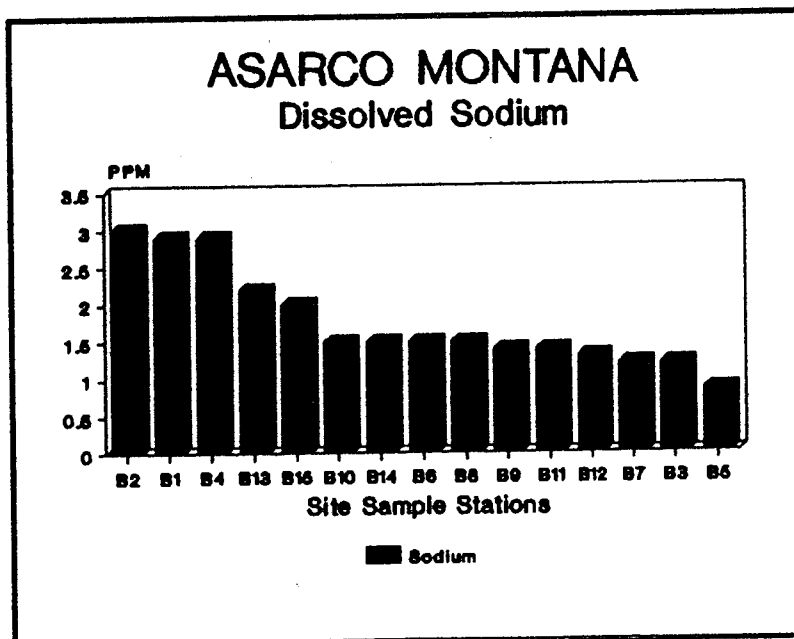
Figure 3a: Upper Blackfoot Potassium

Figure 3b: Upper Blackfoot Sodium

Figure 3c: Upper Blackfoot Potassium/Sodium

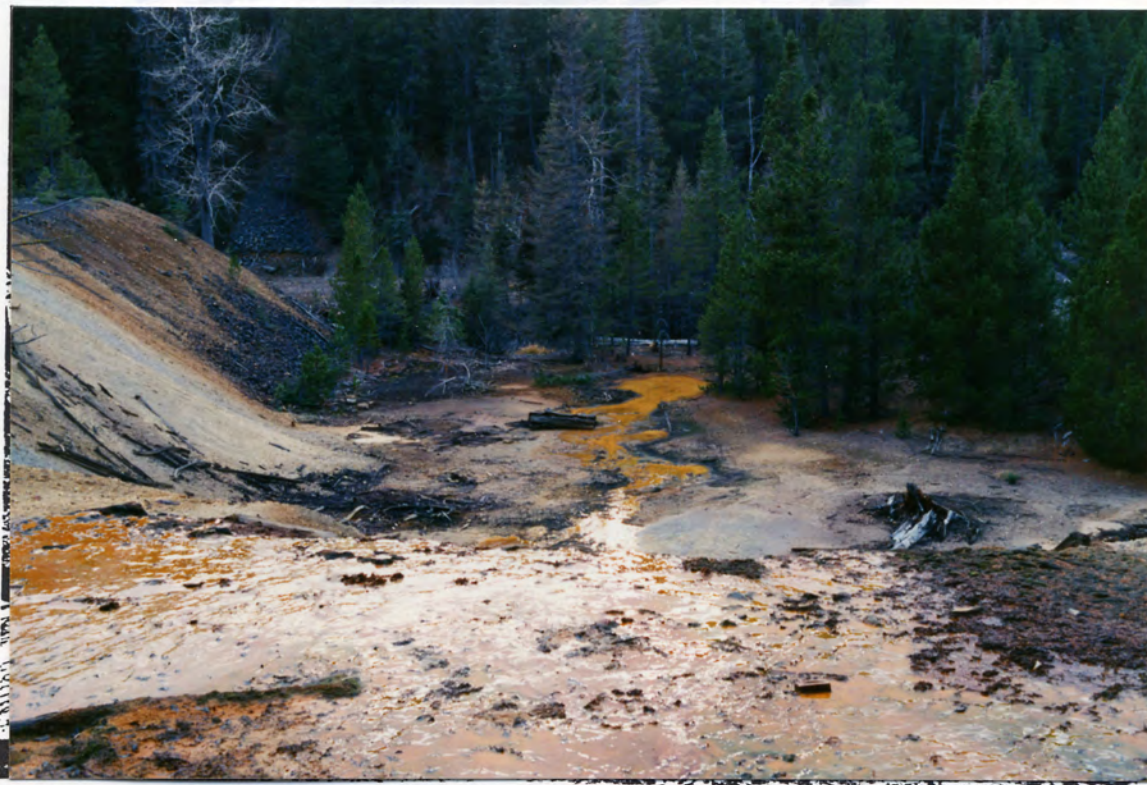
Plate 6: View from the Anaconda portal in seepage direction October 23, 1989 (Station 13, Map 2)

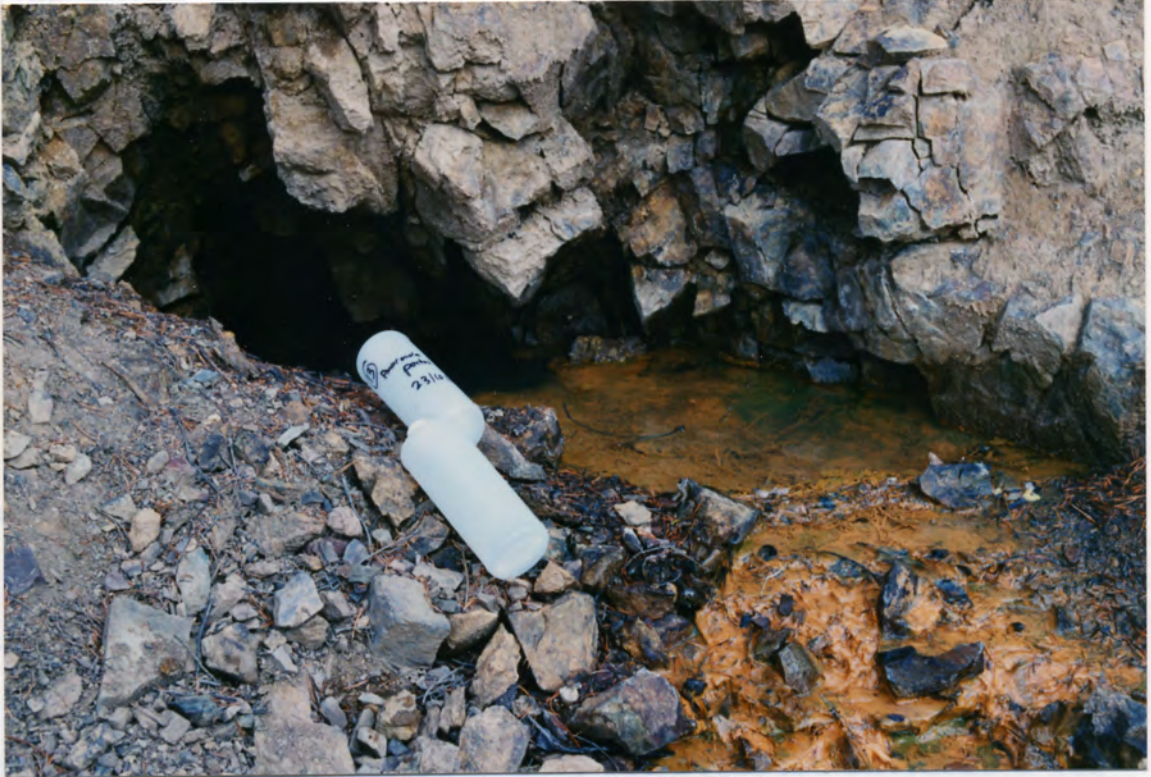
**Plate 8:** Precipitate formation in the Anaconda portal with attached filamentous algae. October 23 1989 (Station 13, Map 2).

Although the Mike Horse and Anaconda portals, with their emerging seepage, are point sources of Zn and Mn, a natural filtration and fixation process occurs in the contaminated seepage streams, immediately as the effluent emerges from the portals. In Plate 10, the algal mats growing in the Mike Horse creek, just below Station B9, are depicted. This material was collected for the determination of elemental composition as well as precipitate from the Mike Horse portal without algae.

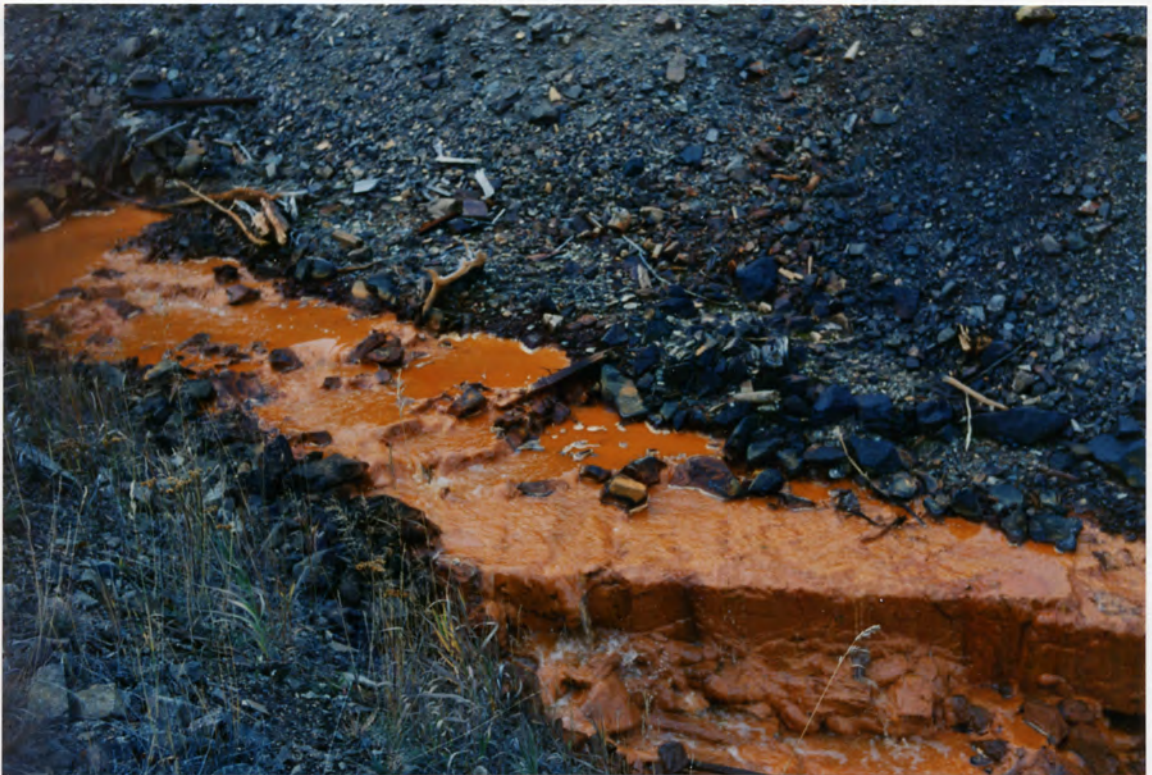
**Plate 9:** Precipitate formation in the Mike Horse creek bed before Station B9 without attached algae. October 23, 1989. (Around monitoring Station P4, Map 1)

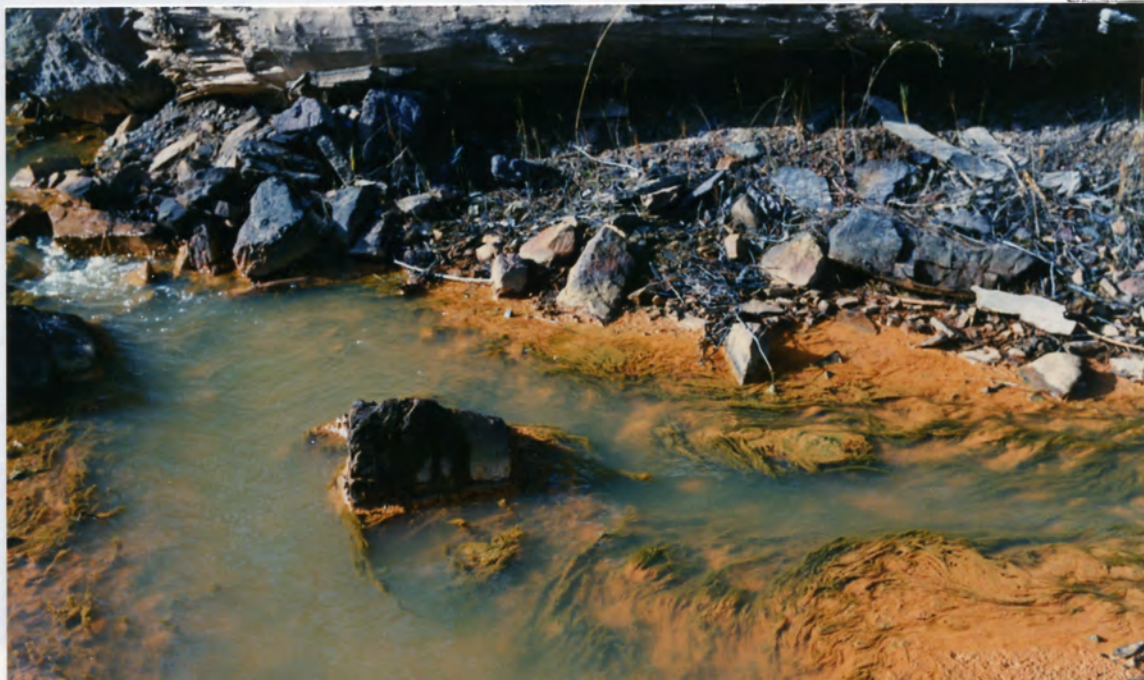
Plate 10: Filamentous algae attached to rock in Mike Horse creek below Station B9

For the effluent and the iron precipitate (yellowboy) from the Mike Horse and the Anaconda portal, it could be envisaged that by increasing the surface areas for growth of algal populations, enhancement of precipitate fixation in the creek bed could be achieved. The tailings pond at the Carbonate could be contoured in such a way as to provide similar conditions to those in the area of the tailings deposit, where indigenous vegetation is growing on the tailings. It is likely that this would reduce metals leaving the tailings pond to the swamp and stabilize the presently exposed and slightly eroding tailings surfaces. Such measures would likely produce no significant disturbance to the Upper Blackfoot river water quality in either the short or long term.

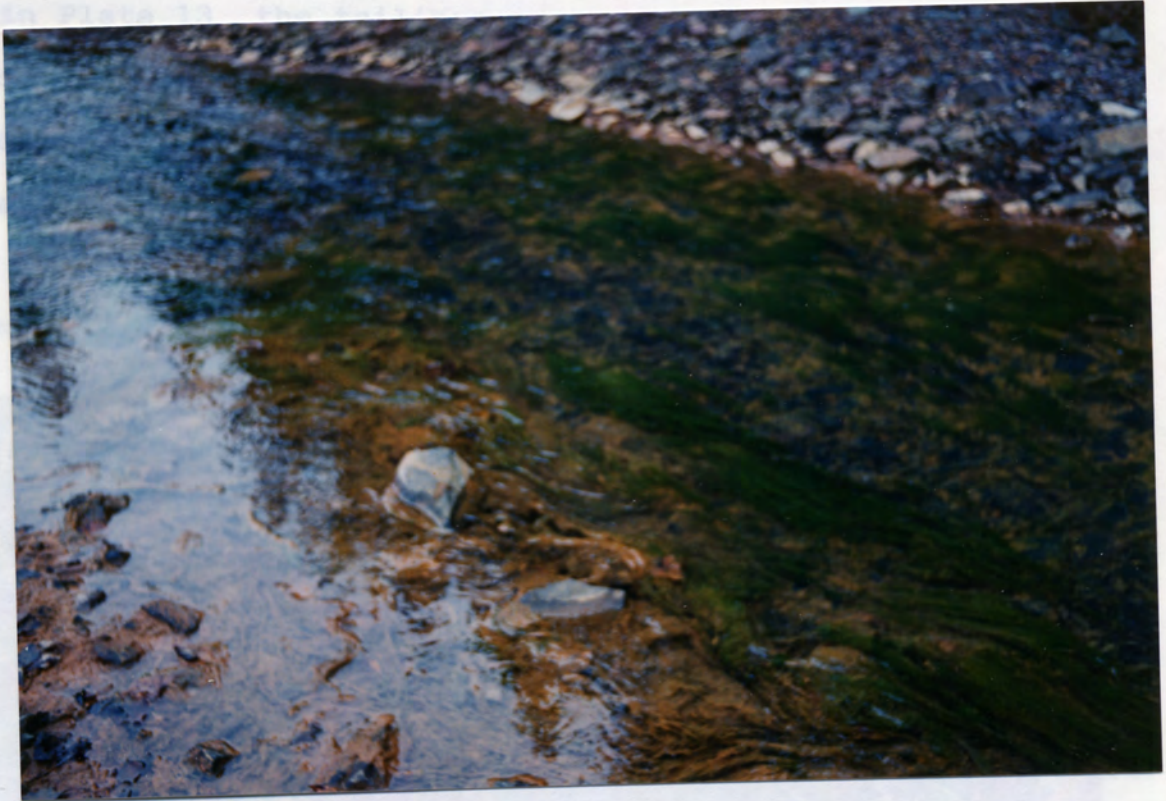
As the precipitate disappears in the creek bed, green filamentous algae, virtually free of precipitate, colonizes the headwaters of Bearfoot river as depicted in Plate 12.

**Plate 12:** Green filamentous algae, virtually free of precipitate in the headwaters of the Bearfoot river. October 23, 1989 (Station 11, Map 2).

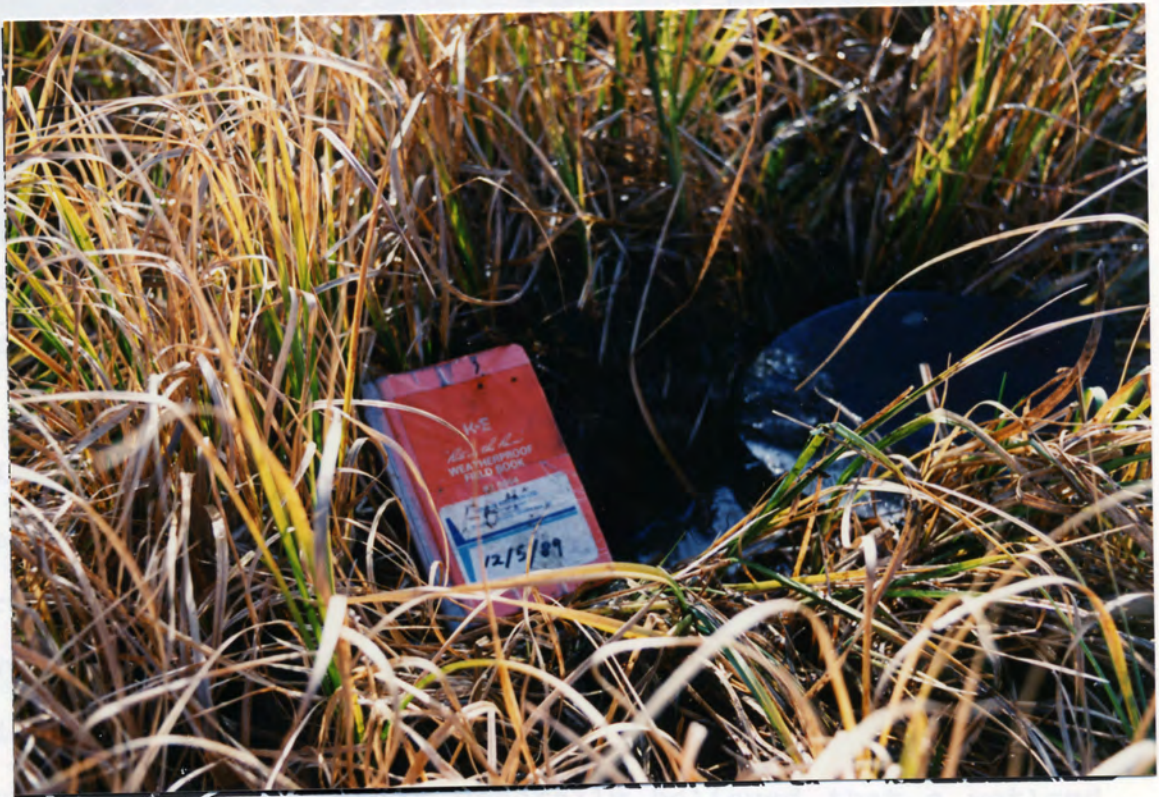
Plate 13: Wetland vegetation colonizing the moist carbonate tailings

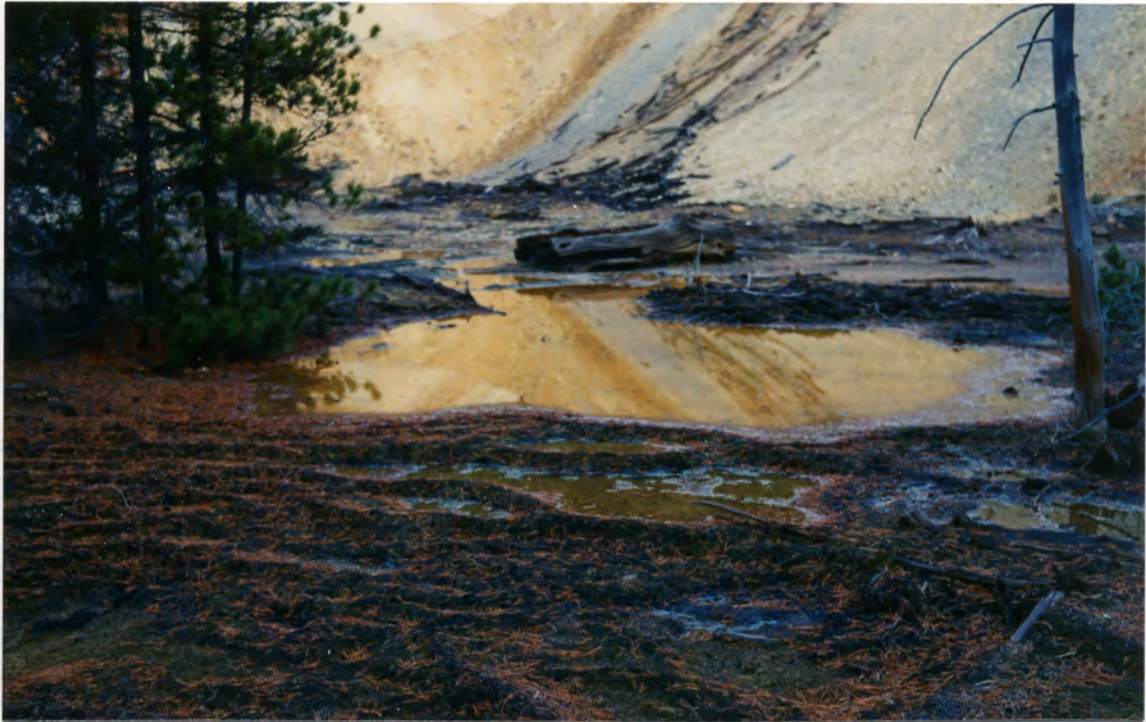
The seepage from the Anaconda workings disappears in a natural depression below the workings and the tailings waste rock dump (Plate 14). The area is covered with an extensive growth of moss serving as a filtration/absorption cover for precipitate and metals.

Plate 14: Natural Polishing area below the Anaconda portal

system which has been described, being algal growth and moss and vegetation covers for precipitate and metals. In fact, these processes are utilized in Ecological Engineering and Biological Polishing methods. These water treatment measures can be employed at the time of shut down of mining operations where the remaining mining wastes produce degradation of surface waters. Furthermore any earth moving activities are likely to increase the suspended solids loads, which could have a detrimental effect on the performance of the swamp below the Carbonate tailings. This wetland area is relatively large and has likely served as a significant sink for zinc. It is therefore essential to maintain this bog in a healthy condition.
